NOTICE TO MARINERS

LOWESTOFT APPROACHES – POSSIBLE SHOALING EAST OF HARBOUR ENTRANCE

16th January 2019

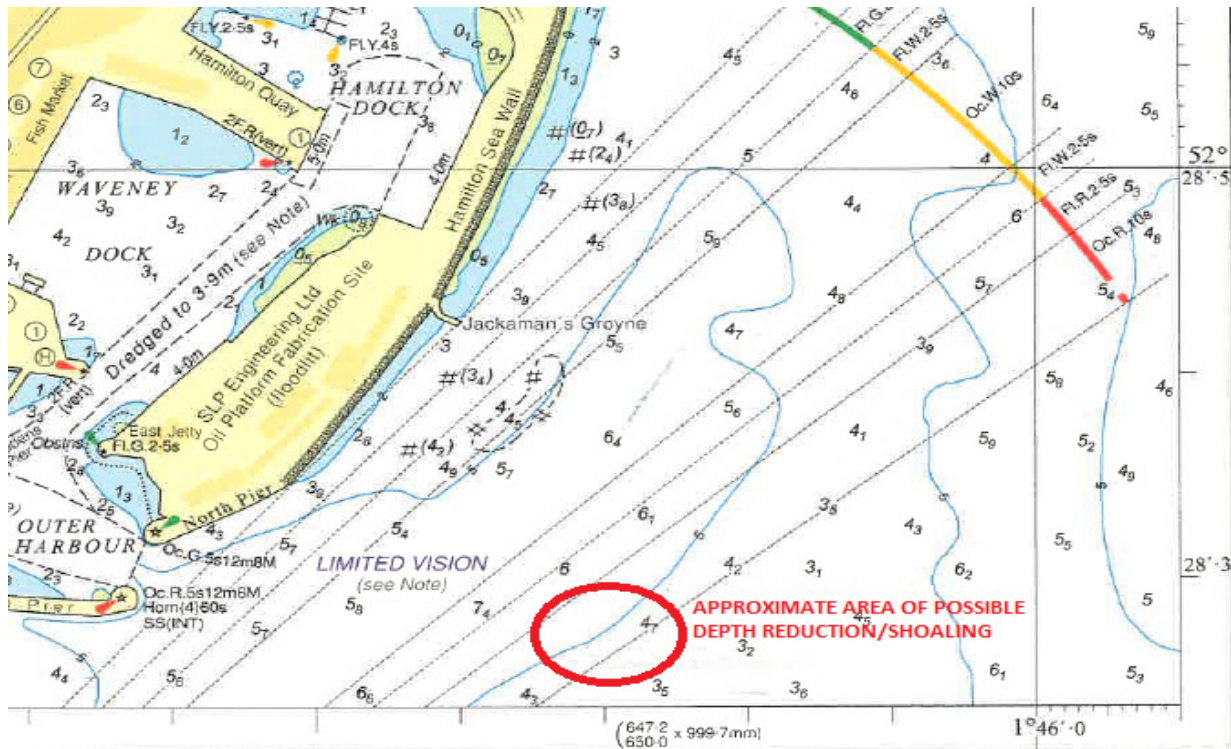
Mariners and Port Users are advised of an area of suspected shoaling approx. 350 metres East of Lowestoft Harbour entrance, centred on approx. position 52° 28.260'N, 001° 45.700'E.

This shoaling has yet to be confirmed, but may have resulted in depth reduction of between 0.5m and 1.0m. This area is shown on the chart extract below.

The area of concern would appear to be within the occulting red sector of the port entry light. This light is an aid to navigation but should not be solely relied upon for an indication of vessel position.

Mariners and Navigators are requested to navigate with caution when in Lowestoft Harbour approaches, using all means available to check and verify vessel position to ensure that the required under keel clearance is available.

A survey of this area will be arranged to verify depths. The results of this survey will be promulgated once available.
