# Broads Authority

## Cultural Heritage Survey Sheet

### Stokesby with Herringby, Old Hall Mill & Cottage.

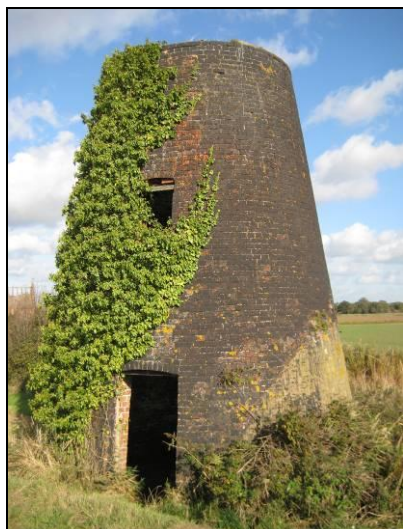
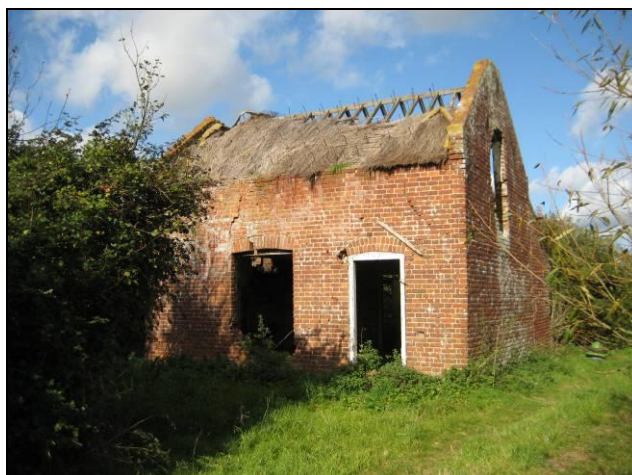
<b>Cultural Heritage ID No:</b> - None	<b>Inspection date(s):</b> - Ben Hogg & Prue Smith 12/08/08 & 21/10/08	<b>Location, Address and Grid Ref:</b> -	
<b>Listed Grade:</b> - (N/L, N/PL) N/L	<b>Fragility:</b> - (1 – 3)	<b>Mill 1 Cottage 1</b>	<b>Vulnerability:</b> - <b>Mill 1 Cottage 1</b> (1 – 3)
<b>Photographs:</b> - Mill - IMG 0563 – 4, 0937 – 40. Cottage IMG 0941 - 43		<b>BAR Risk Grade:</b> - (A – F)	<b>A</b>
List description / Context: - <b>Mill</b> - Small 19c? tarred brick tower mill. No cap, joinery or machinery. Accessible beside river bank. <b>Cottage</b> - 2 storey 19c redbrick, evidence of thatched roof.			
<b>Comments:</b> -. Remains of first floor construction evident internally, unusual floor/supports at 2 <sup>nd</sup> floor level? No obvious cracking in b/w and openings and arches seem stable. B/w spalling internally. Severe ivy growth to west of tower and signs of vandalism.  Mill Cottage – in very poor condition – all joinery & thatch missing, rafters and floor joists exposed and collapsing. B/w collapsing due to vandalism which is also evident internally.  NB. 12/08/08 - both inspected from river, cottage barely visible. 21/10/08 - Inspected on foot.

<b>Threat posed:</b> - <b>Mill</b> - Ivy growth and vandalism, water damage to brickwork. <b>Cottage</b> – Roof and floor timbers exposed to elements, vandalism.			
<b>Conclusion / Recommendation:</b> - <b>Immediate:</b> <ul style="list-style-type: none"> <li>• <b>Mill</b> – secure, temporary cap, block openings, remove ivy.</li> <li>• <b>Cottage</b> – Secure, block openings, remove ivy, temporary roof covering.</li> </ul> <b>Medium/long term</b> <ul style="list-style-type: none"> <li>• Consider future ownership/use and repairs</li> </ul>
