Navigation Committee

Carrow Road Bridge repairs

Report by Chief Executive and Director of Operations

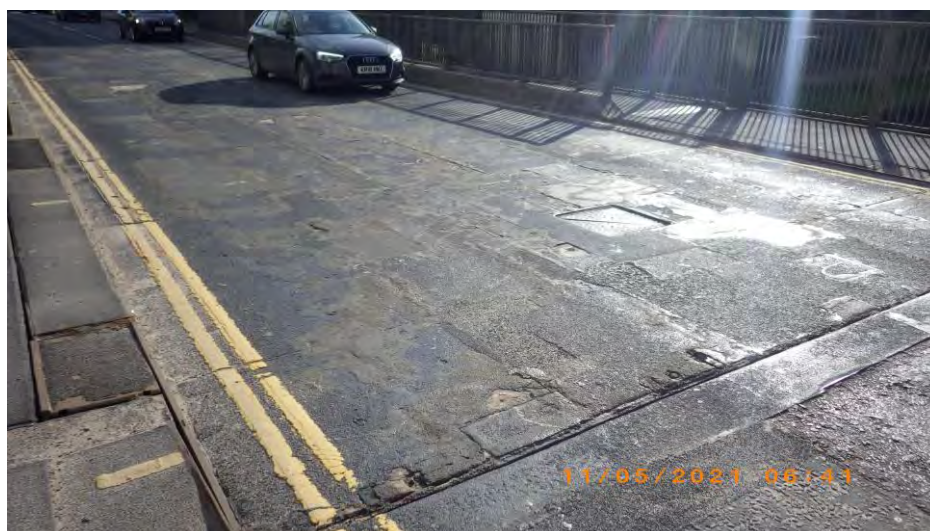
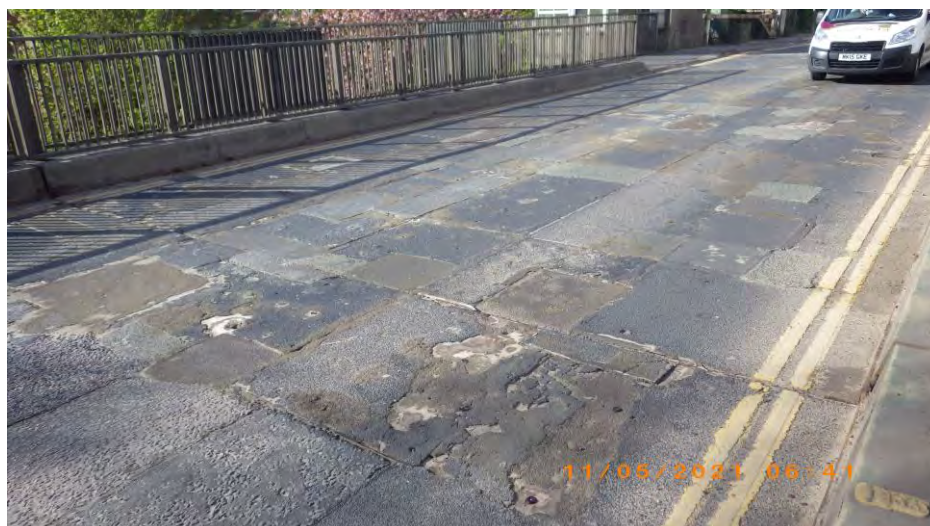
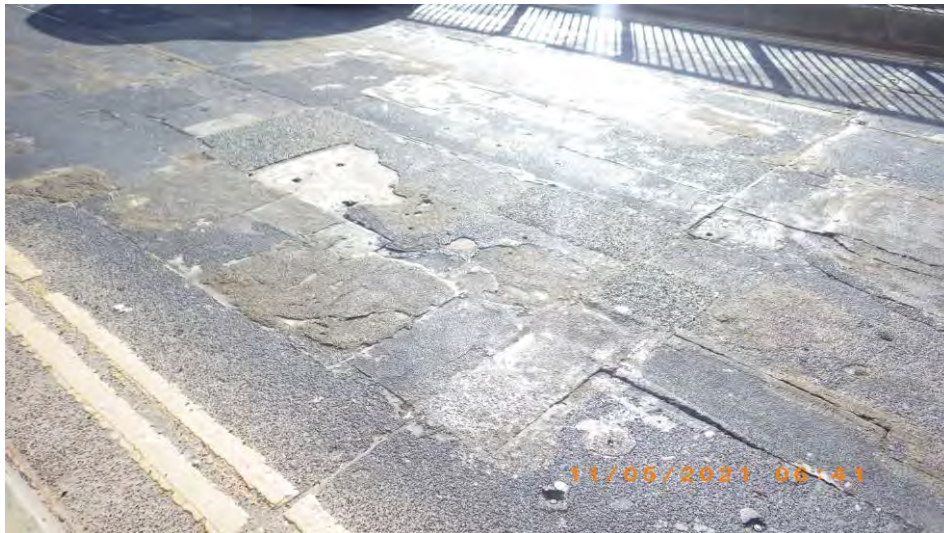
Figure 1: Photos illustrating the condition of the bridge deck

- 3.6 The bridge deck repairs are reaching the end of their life. The bridge deck concrete has been drilled into so many times over the past two decades, that it is becoming increasingly difficult to connect into solid concrete and achieve the required bolt embedment.

- 3.7 The photos below in Figure 1 illustrate the poor condition of the existing bridge deck. As the bridge is a bascule bridge which opens, the deck itself has to be of lightweight materials. As well as the fixings into the existing concrete being difficult due to the number of times the concrete has been drilled into over the past decades, these lightweight materials are not as durable as a more substantial and heavier deck plates. However, the bridge could not lift using these more substantial materials. Additional photos of the bridge deck can be found in Appendix B.

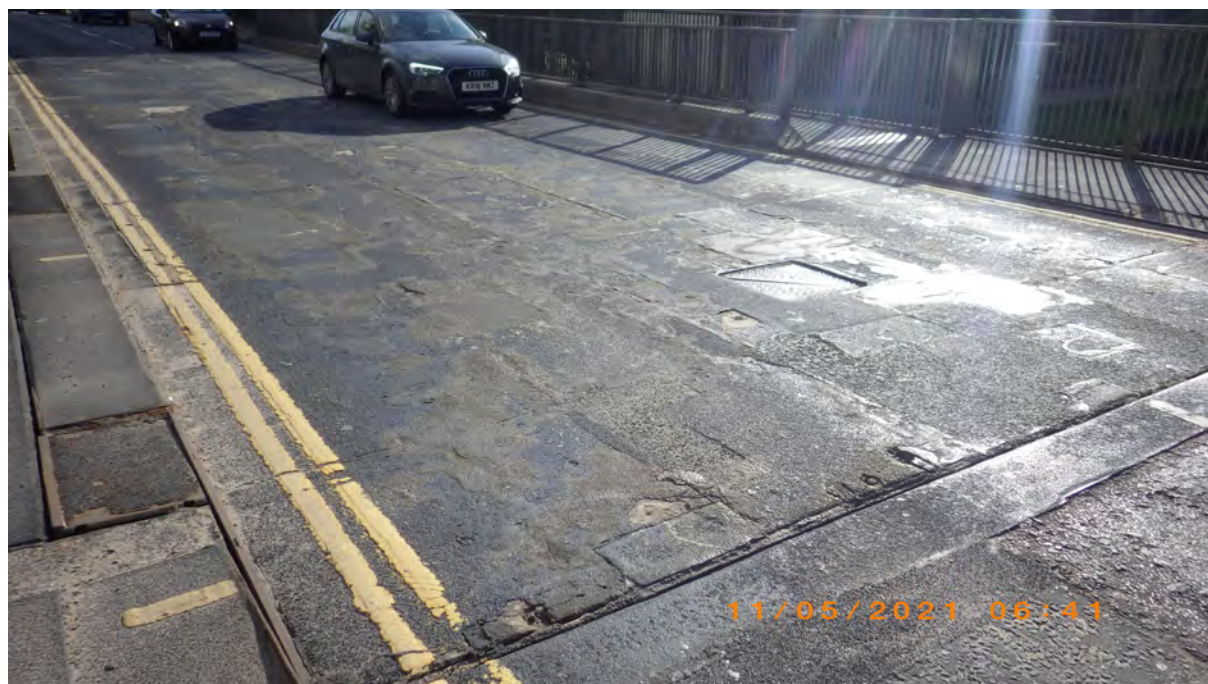
Four photographs taken on 11/05/2021 to show current condition of the carriageway surfacing, along with two photographs showing the condition on 10/09/2018 to give an indication of the deterioration since then.

Photograph 1. Looking northwards towards football stadium side.

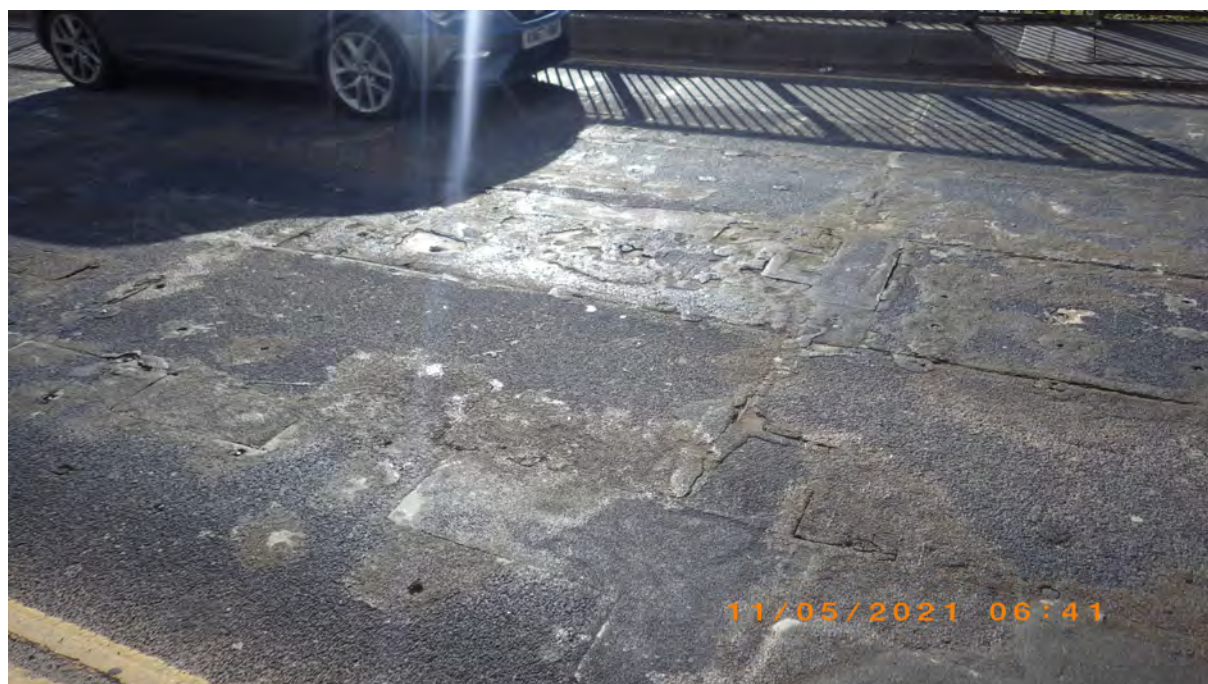
Photograph 2. General view.

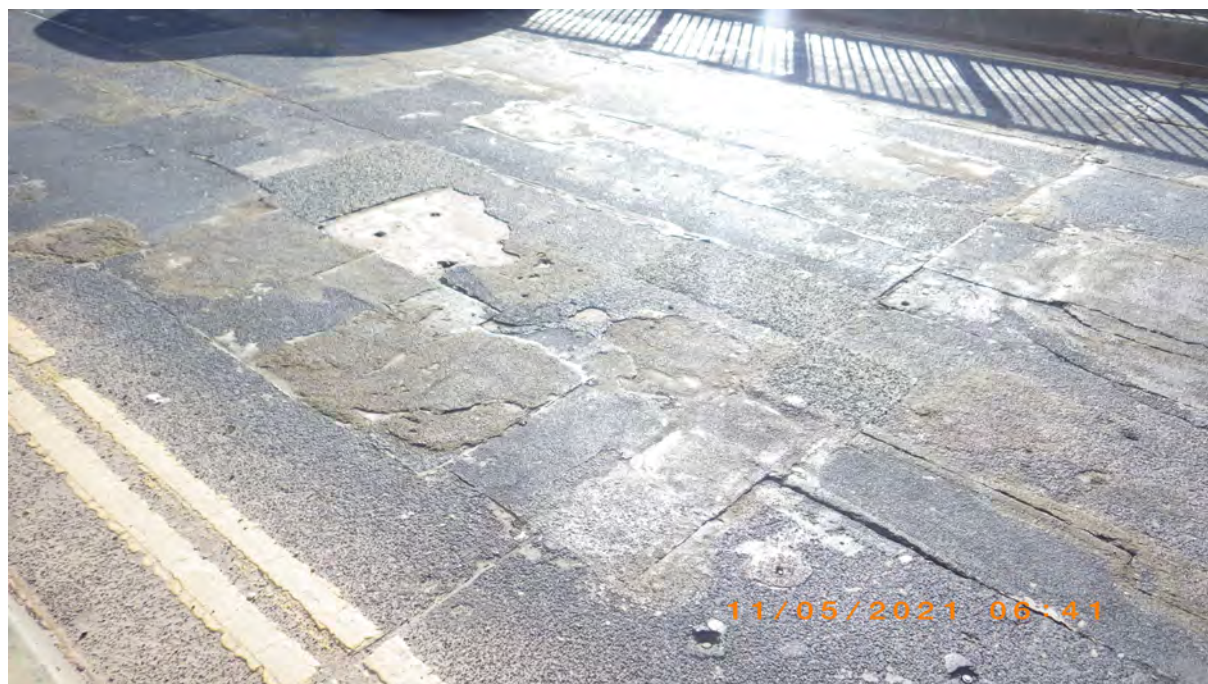
Photograph 3. General view.

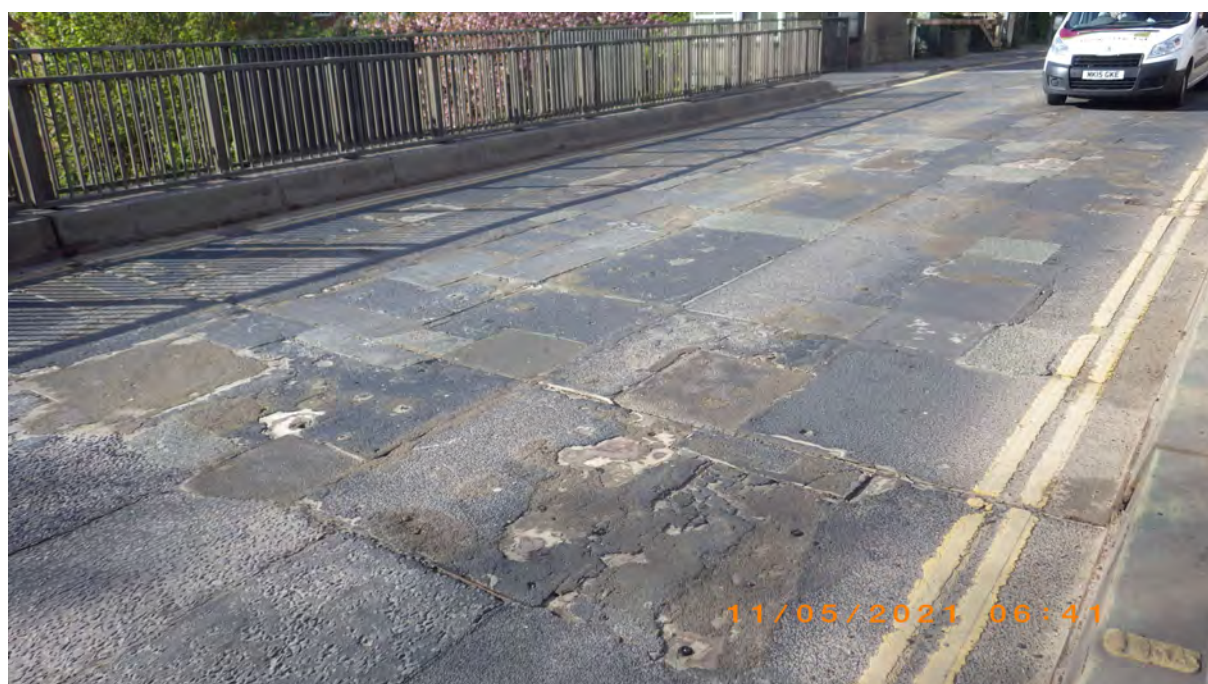
Photograph 4. Looking southwards towards County Hall side.

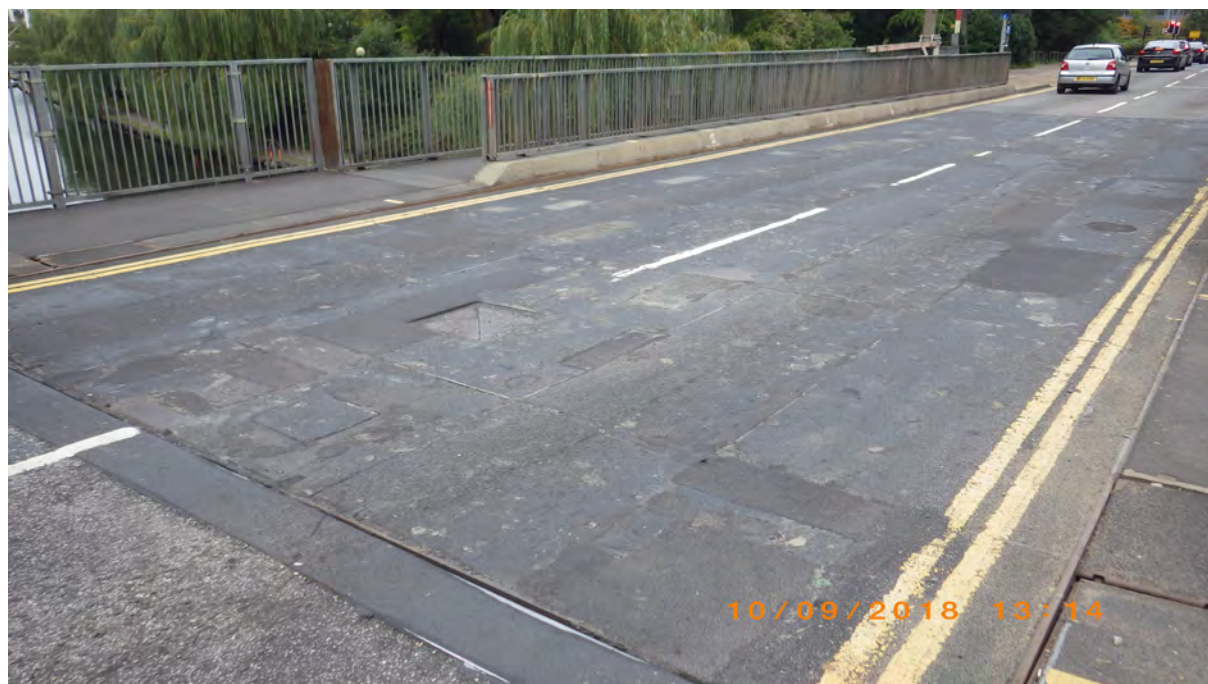
Photograph 5. Looking northwards towards football stadium side. 2018.

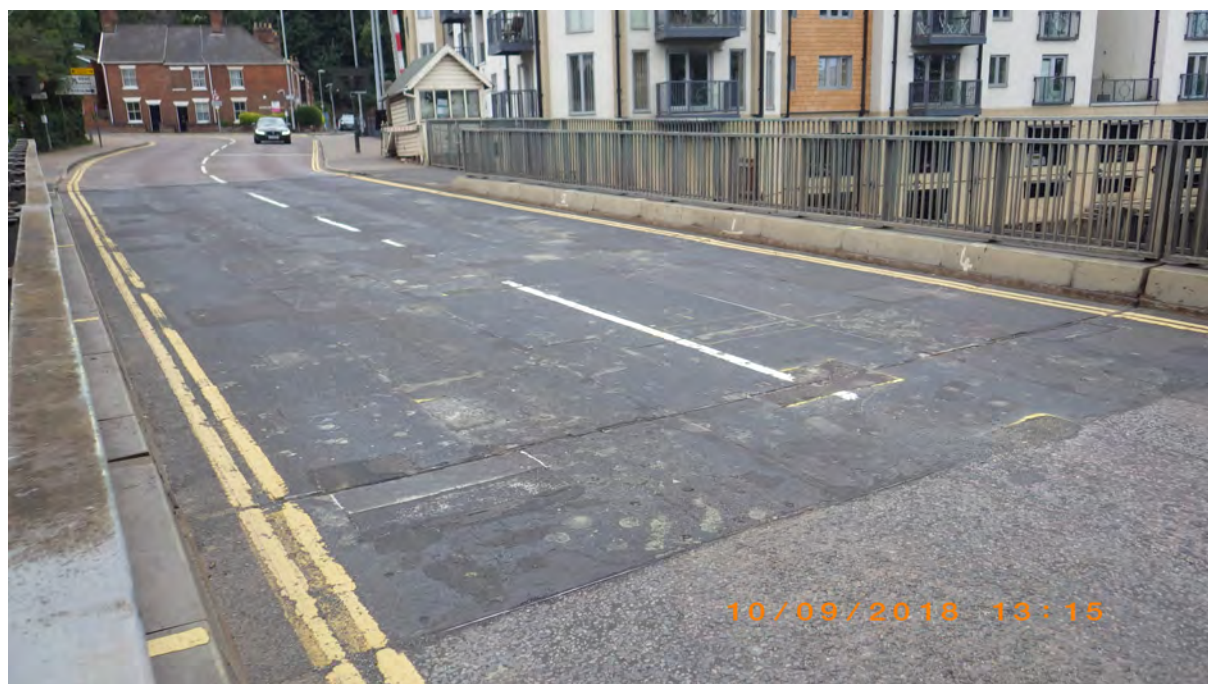
Photograph 6. Looking southwards towards County Hall side. 2018.

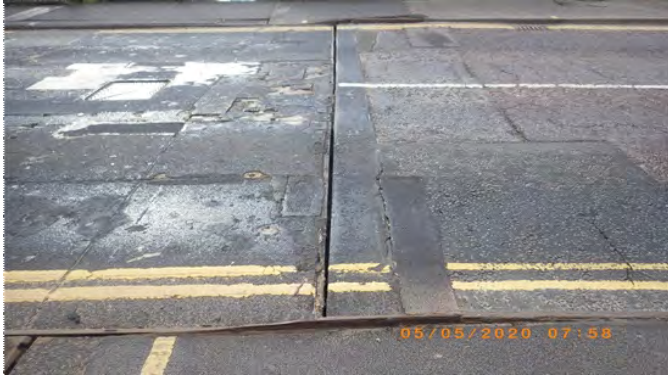
Steel Noising Bouncing Due to possible Broken Weld

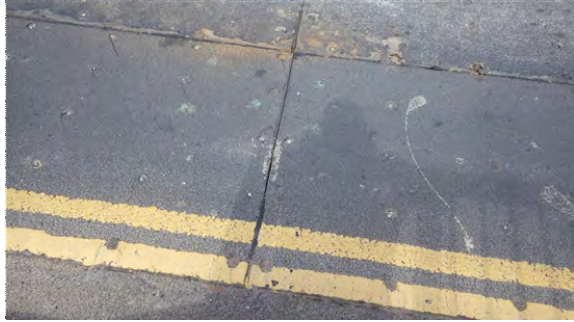
Recommended Works								
No.	Description	S	EX	Def	W	P	Cost	Comments
24	Carriageway surface	5	E	9.4	R	H	£35,000	Areas of surface texture loss, open holding down bolt fixing holes, loose fixings and bouncing boards - Repair. Works will require 2 night road closure.

Typical Loose Fixings

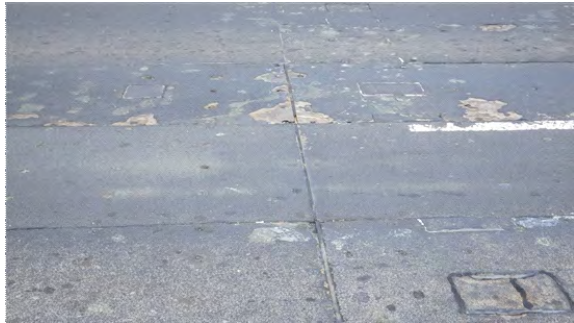
Typical Anti Slip Surface Lose

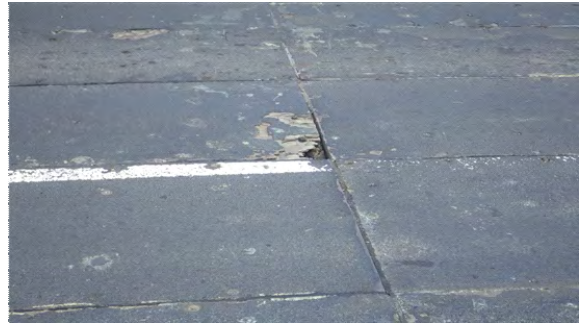
Broken Corner to Deck Board

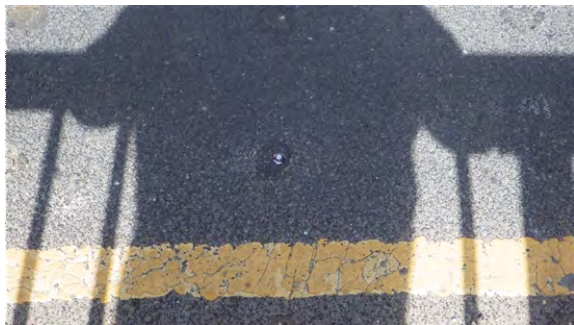
Fixing proud of Surface

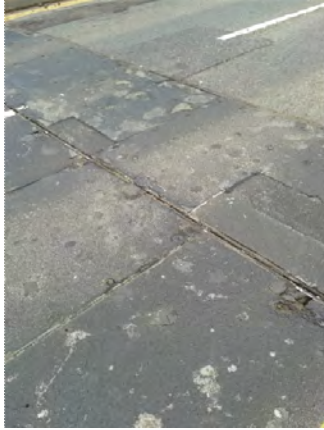
No.	Description	S	EX	Def	W	P	Cost	Comments
24	Carriageway surface	3	C	9.1	R	H	£8,000	Areas of surface texture loss, open holding down bolt fixing holes and bouncing boards identified on attached drawing - Repair. Works will require 2 nights with convoy working due to works in centre of carriageway.

Typical view on Deck Board requiring probable replacement next financial year. a

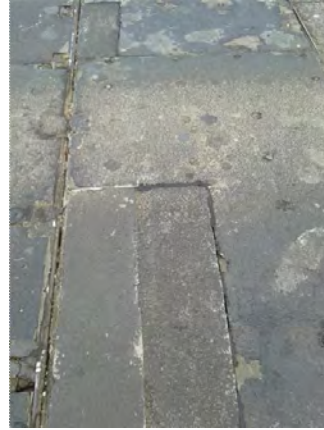
Typical view on Deck Board requiring probable replacement next financial year. c

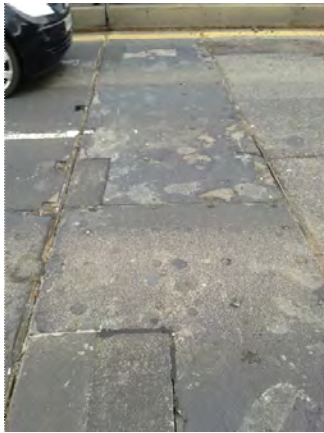
Typical view on Deck Board requiring probable replacement next financial year. d

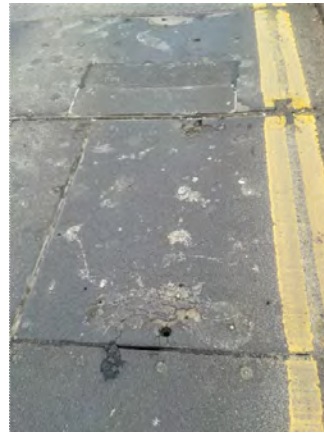
Typical view on Deck Board requiring probable replacement next financial year. b
