Breydon Water Navigation Works
Report by the River Engineer

Author: Tom Hunter
Date of report: 26 November 2013

TURNTIDE JETTY STRUCTURAL CONDITION SURVEY AND RECOMMENDATIONS

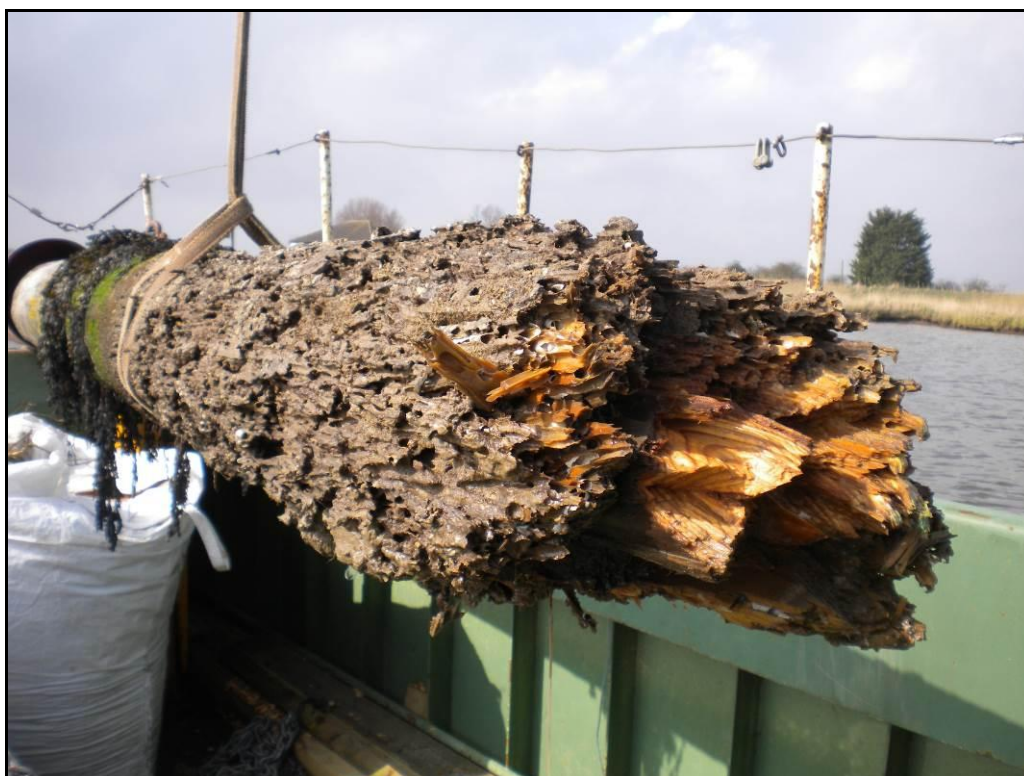
Photo 1: Broken navigation marker with significant gribble worm attack.

- 2.1.3 Gribble worm is common in marine estuaries and Breydon Water is no exception. These small crustaceans bore into the timber and therefore exacerbate the progression of rot. Gribble worm will bore into any timber but softwood is particularly vulnerable.

- 2.1.4 The majority of replacement markers installed over the last year have been hardwood (greenheart), which has a good resistance to both biological attack and rot. However, as the issue has become clearer officers will consider using steel tubes in future replacements. Steel tubes also deteriorate due to corrosion, however, with a good paint system and wall thickness; they should offer good durability. The table below provides some estimated life costs for different piles in Breydon Water. This shows that steel tubes are a viable alternative to hardwood and certainly provide better value than softwood even without taking into account the cost of more frequent mobilisation.

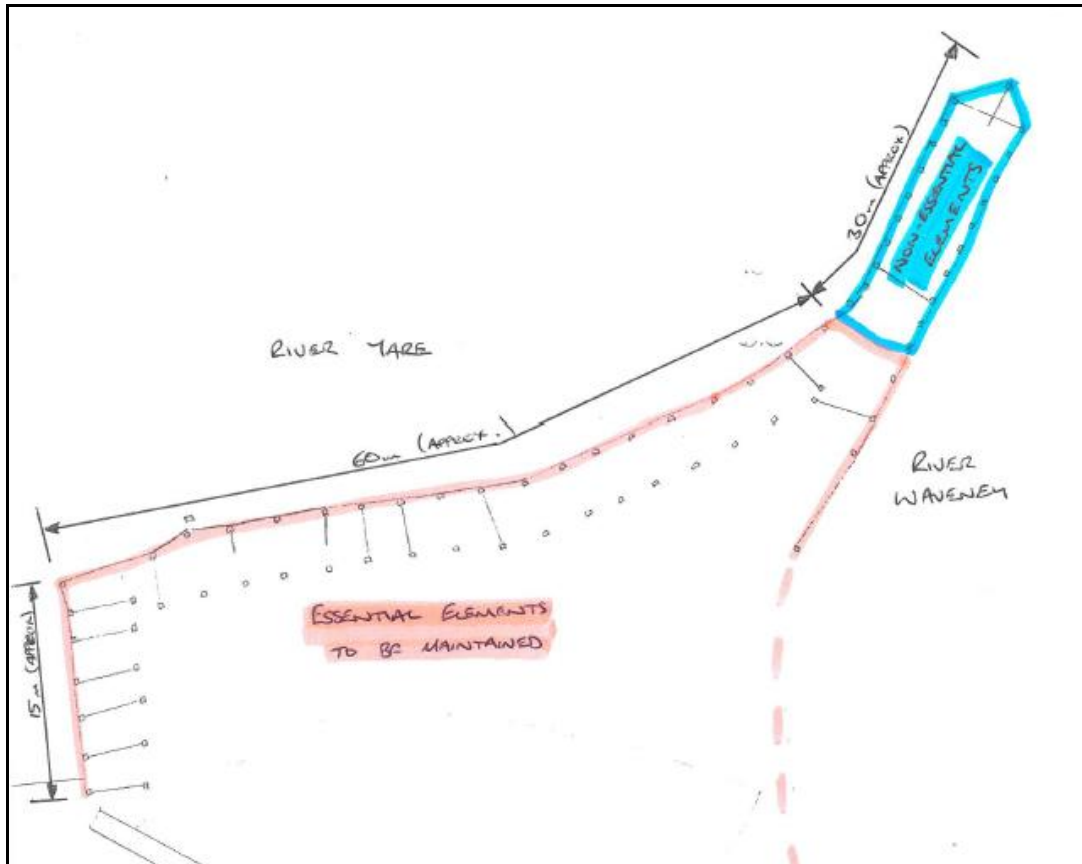
- 3.3 The hydromorphological study suggested that the Jetty does provide a beneficial function with regard to training water flows along the main channel. The study however suggests that the Jetty would continue to be effective without the existing narrow downstream extent (coloured blue in the figure below).

Figure 1: Turntide Jetty showing essential and non-essential parts

- 3.4 Therefore the recommendations of the report are to:
- (i) improve navigation marking over the whole structure
 - to be completed before April 2014 (included in budgeted programme)
 - estimated cost is £2,500 (local contractor)
 - (ii) install additional steel wire ties to the narrow downstream extent to minimise any movement of elements into the channel
 - to be completed before April 2014 (included in budgeted programme)
 - estimated cost is £2,500 (local contractor)
 - (iii) reconstruct the essential parts of the structure by re-piling either as a single operation or phased, as outlined in the following options.

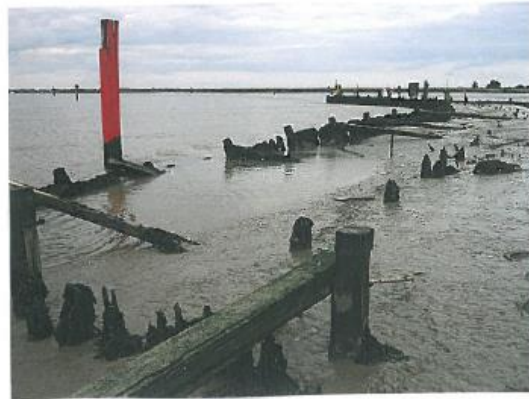
① FAILED PILING

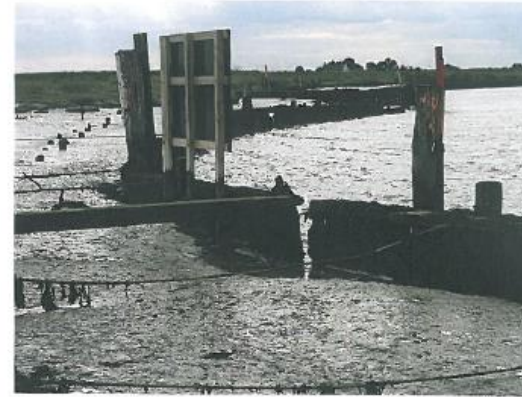
② BROKEN WALING & SLACK TENSION WIRES

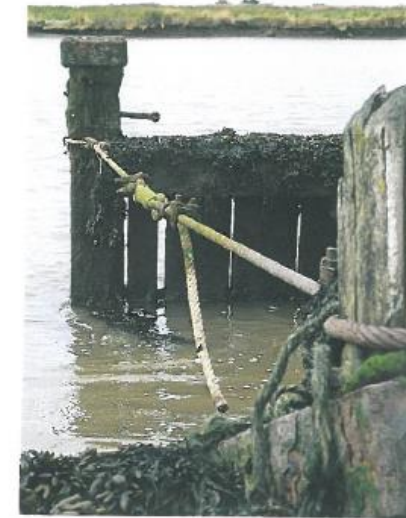
③ TENSION WIRE STILL EFFECTIVE (ADJACENT TO MISSING PILING)

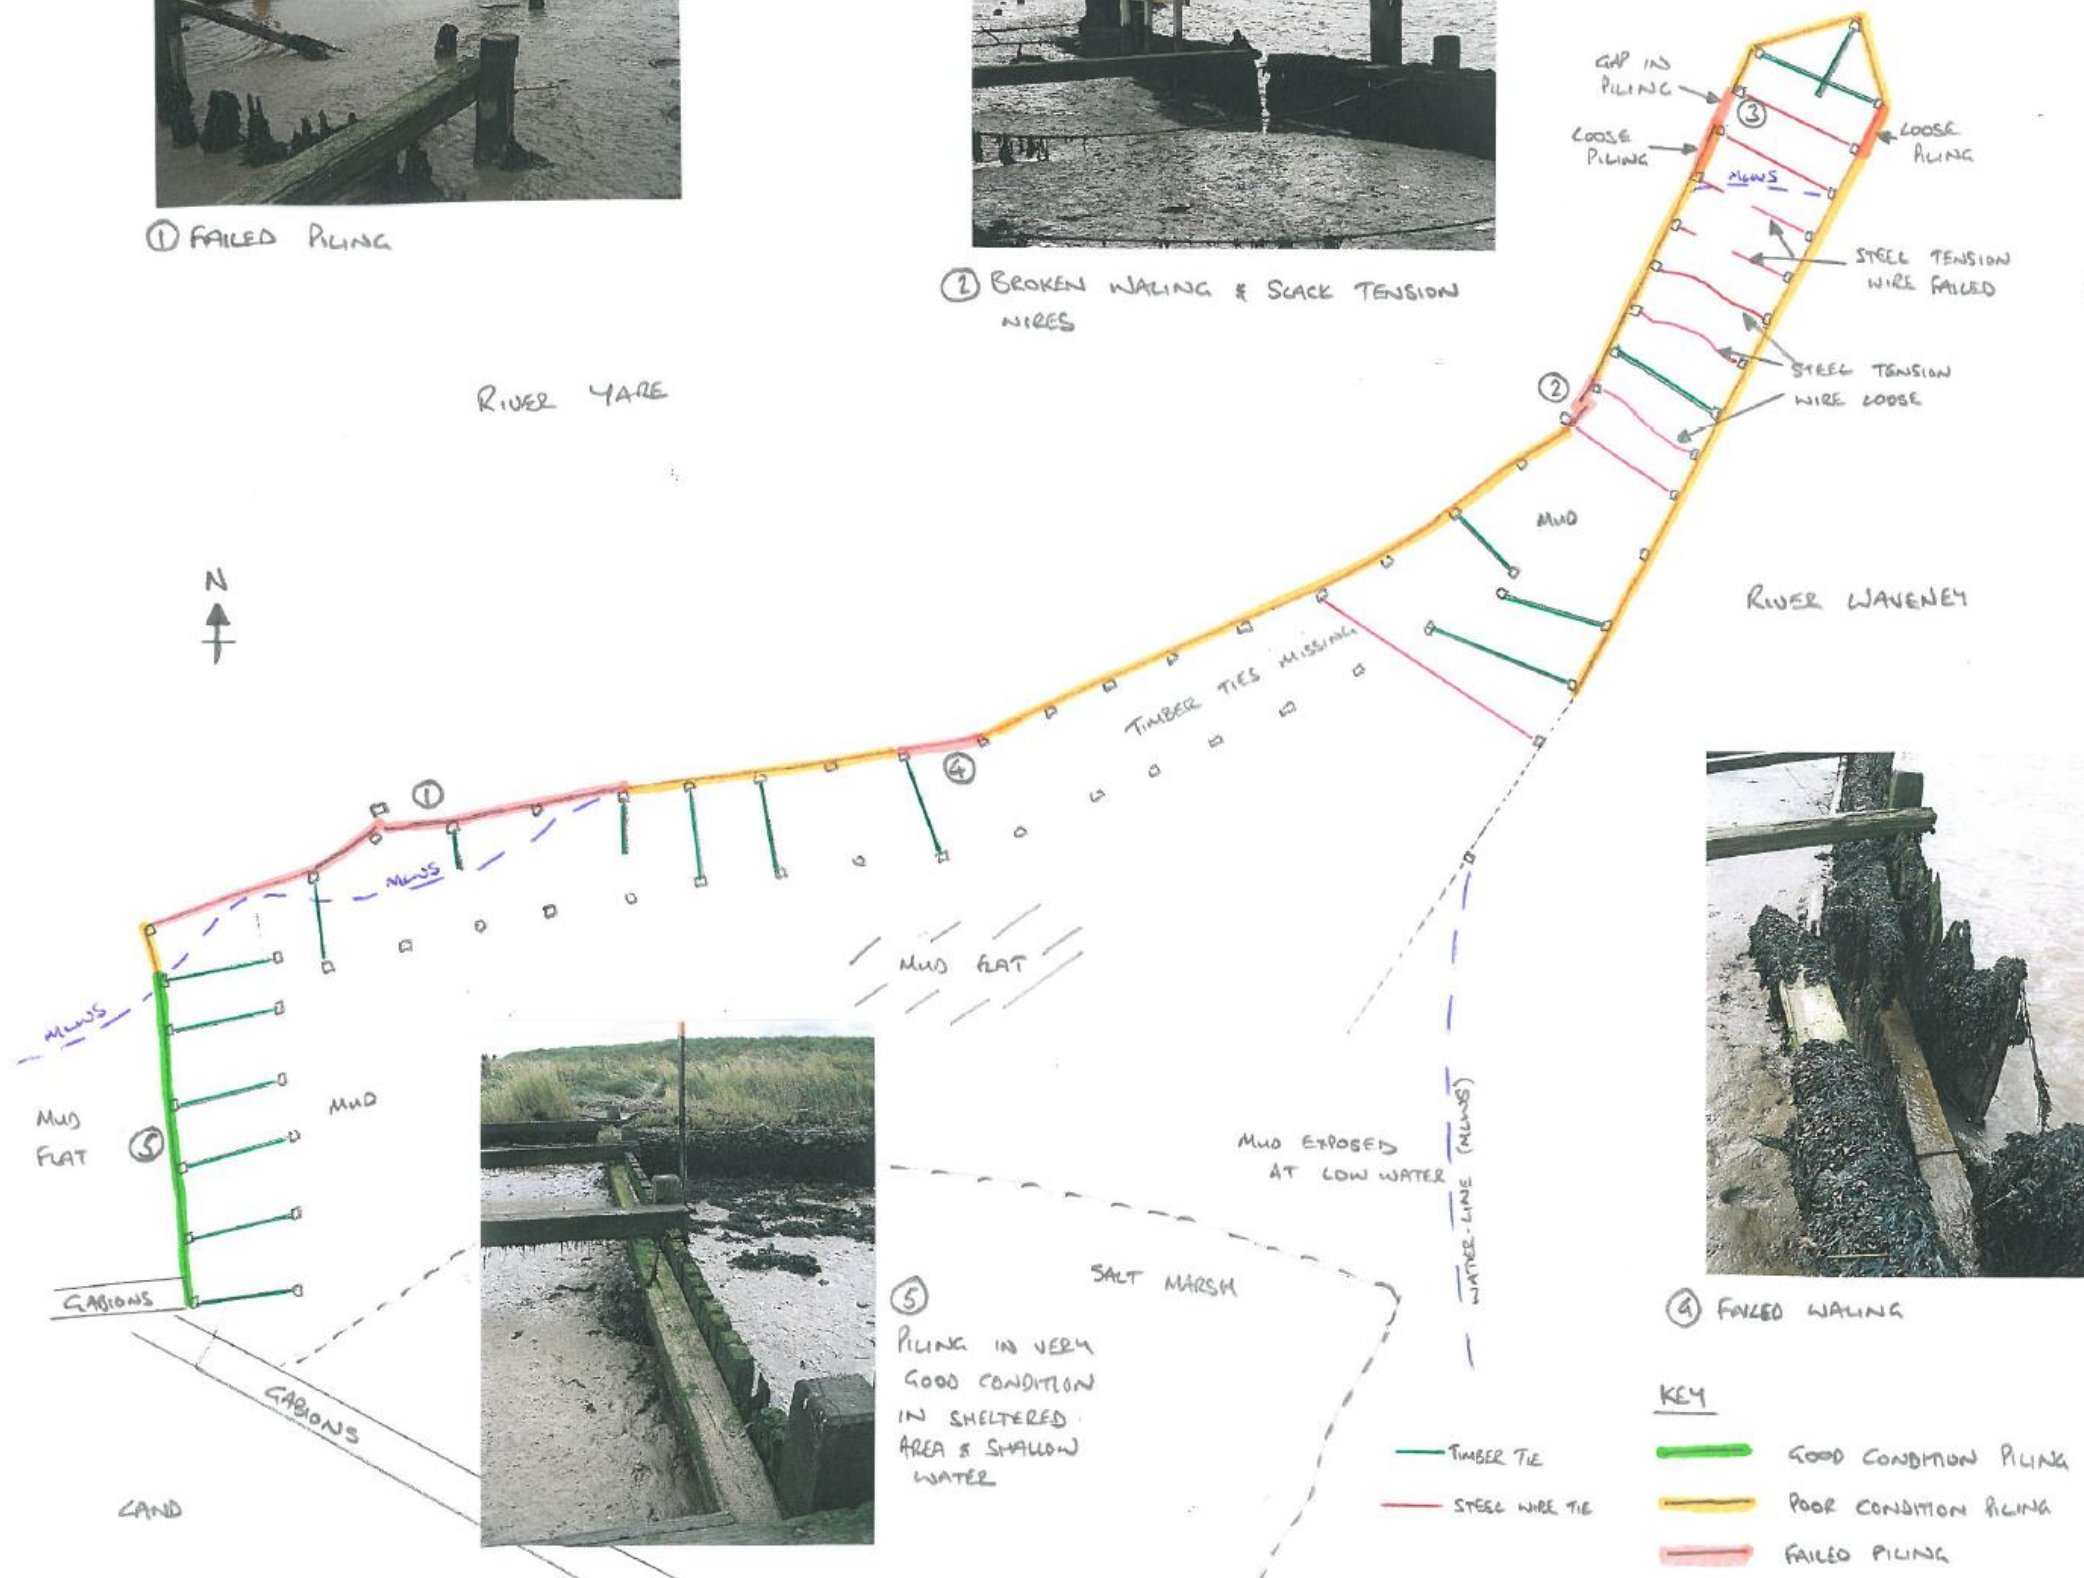
TURNTIDE JETTY
GENERAL CONDITION SEPTEMBER 2013
BROADS AUTHORITY
T. HUNTER OCT. 2013
DRAWING: TTS/2013/002
NOT TO SCALE

Much of the structure remains in place and therefore continues to function as a training structure to the hydraulic flows. However, with the exception of the return at the west end, the general condition of the structure is poor. Many elements, particularly on the erosive River Yare side, have failed or are failing. This is leading to localised loss of fill and progressive collapse of the sheet piled frontage.

As shown in the above figure, the run of piling at the downstream end of the River Yare section is the most vulnerable part and in the poorest condition. It was clear from the survey that the piling is now progressively failing. Historical aerial photographs show that this has significantly deteriorated over the last six years, as shown in the timeline of photographs below.

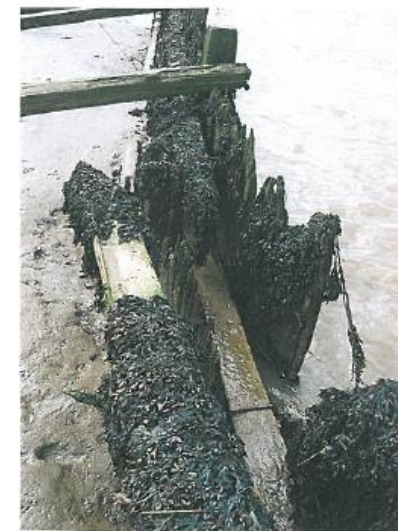
④ FAILED WALING

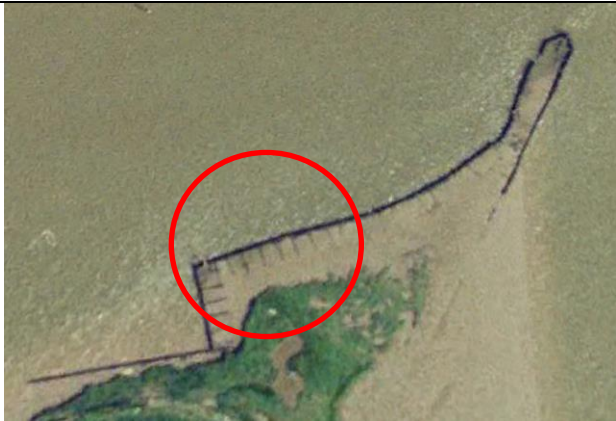
1999 The piling along the Yare face is intact and remains reasonably straight with all anchor ties visible.

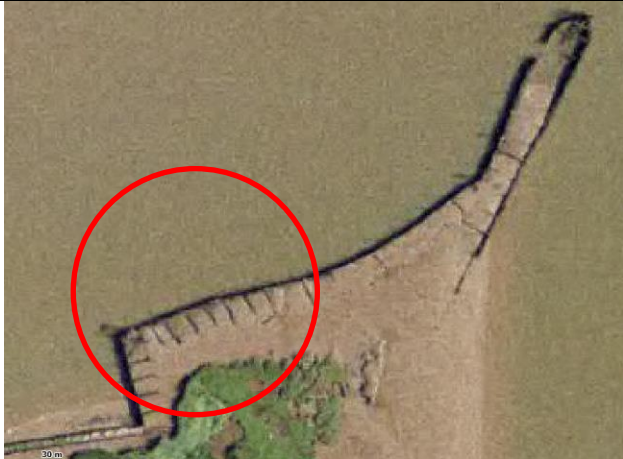
2004 The piling remains intact with all ties visible but piling is starting to bow riverward.

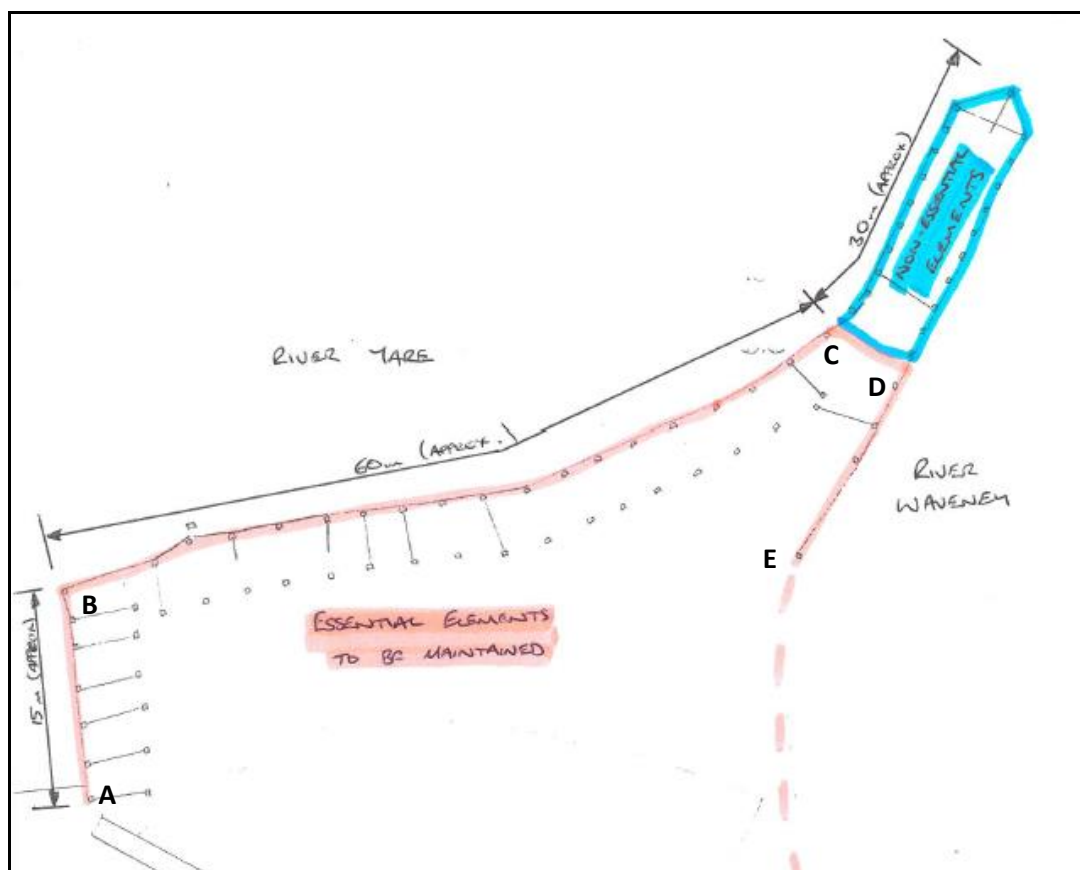
Figure: Layout of the structure showing essential elements

It is recommended that the most effective method of reconstruction will be using anchored steel sheet piling. Sheet piling could be constructed in phases with priority given to the most vulnerable sections. Using the letters shown on the above figure the order of priority for re-piling the essential part of the structure is as shown in the table below.

Priority 1	B-C	Approximate Length 60m Cost estimate £150,000
Priority 2	C-D	Approximate length 7m Cost estimate £30,000 <i>(higher cost per metre due to difficult access to pile face)</i>
Priority 3	A-B	Approximate length 15m Cost estimate £35,000
Priority 4	D-E	Approximate length 20m Cost estimate £50,000

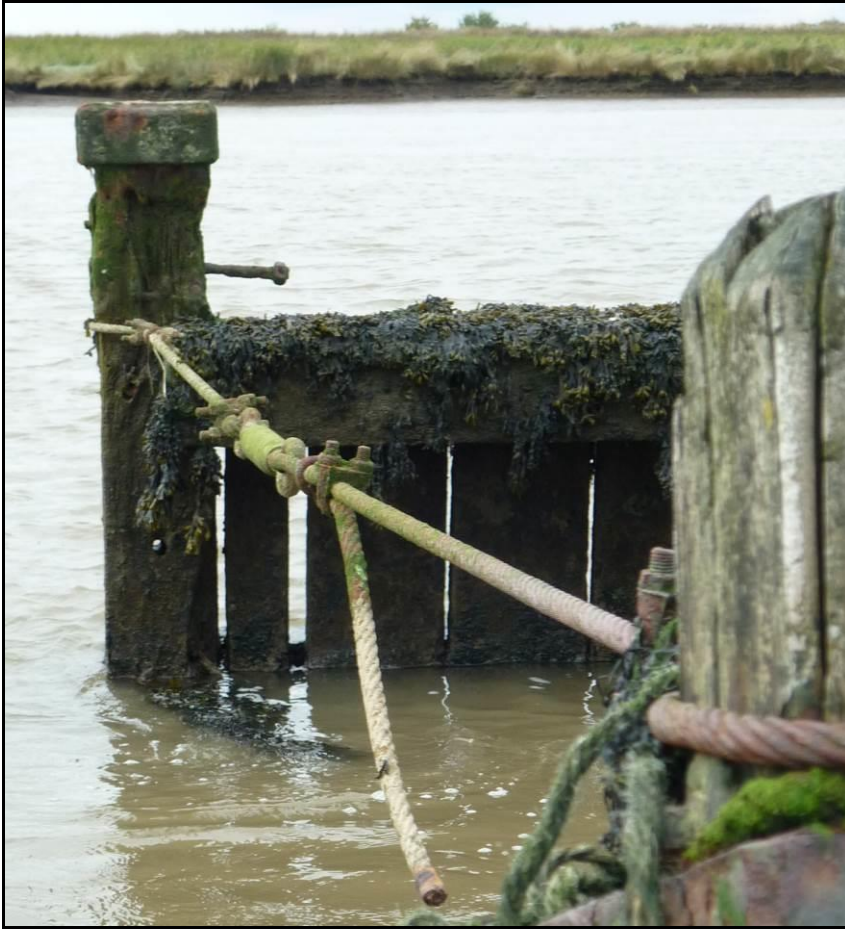
It is apparent that within that last 10-20 years at least eight steel wire cables have been installed on the pier section in place of the original timber ties. The majority of these steel cables have failed or become loose due to slipping of friction grips.

Photo: Steel wire tie (temporary strengthening)

Replacing five of these wire ties is only a temporary measure. However it is a relatively easy measure that will help reduce the risk of outward collapse of the piling as it fails, and therefore reduce the risk of significant navigation hazard. It is recommended that this measure is taken within 1 to 2 years, before much more significant movement occurs.

Wire ties should be installed between any available and sound anchors and king piles. On installation the wires should be brought just to tension to reduce further movement. Wire should not be used to attempt to pull in the existing piling.

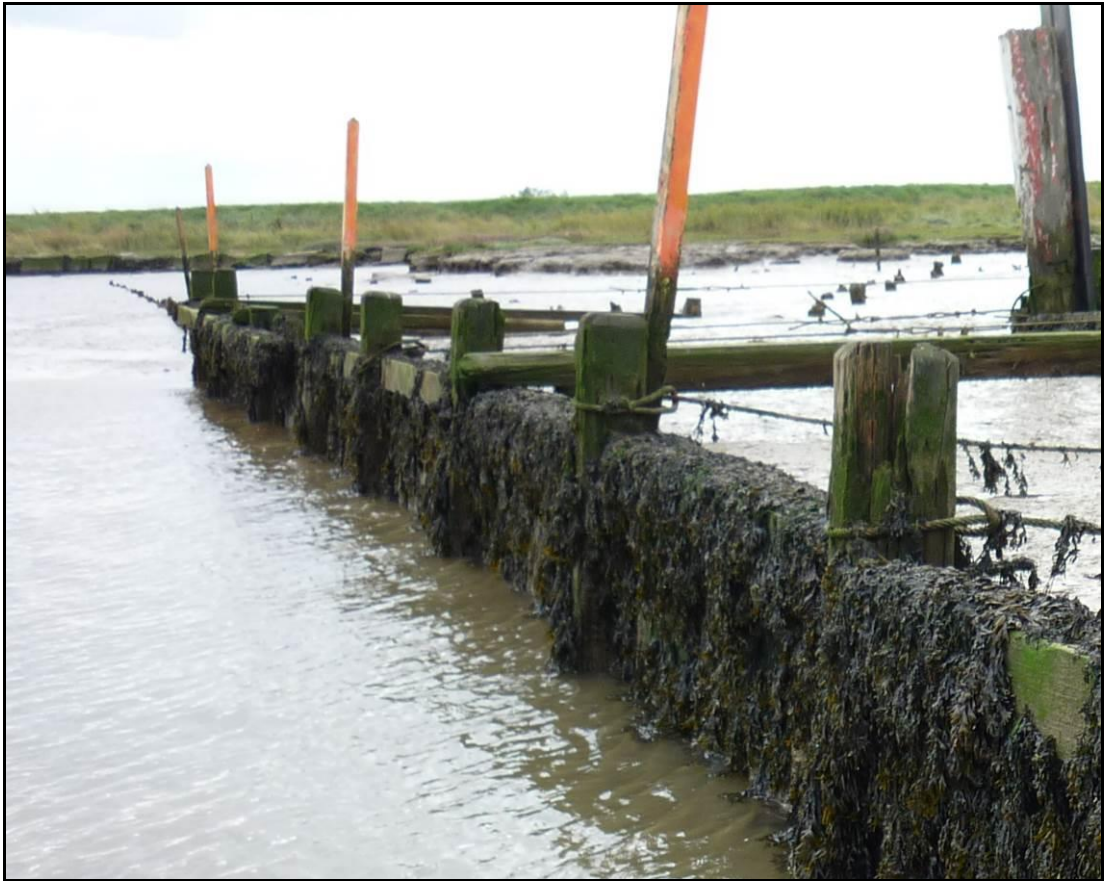
Within the last 10 years the Port of Great Yarmouth installed regular timber up-stand markers which were simply screwed or bolted to the structure. These were painted in a high visibility orange colour. Most of these remain in place but they are small and the paint is now degrading.

Photo: River Waveney side piling showing current orange markers

It is recommended that an immediate measure to improve navigational safety, these markers should be replaced with larger (100mm square) timber markers. These markers should be:

- i. Fixed to the structure at regular intervals not exceeding 5.0m
- ii. Painted yellow, or other appropriate colour to be advised by the Head of Ranger Services
- iii. Extend 2.0m above the top of the existing jetty sheet piling
