**Construction, Maintenance and Environment Work Programme
Progress Update**

Report by Head of Construction, Maintenance and Environment

Summary: This report sets out the progress made in the delivery of the 2015/16 Construction, Maintenance and Environment Section work programme.

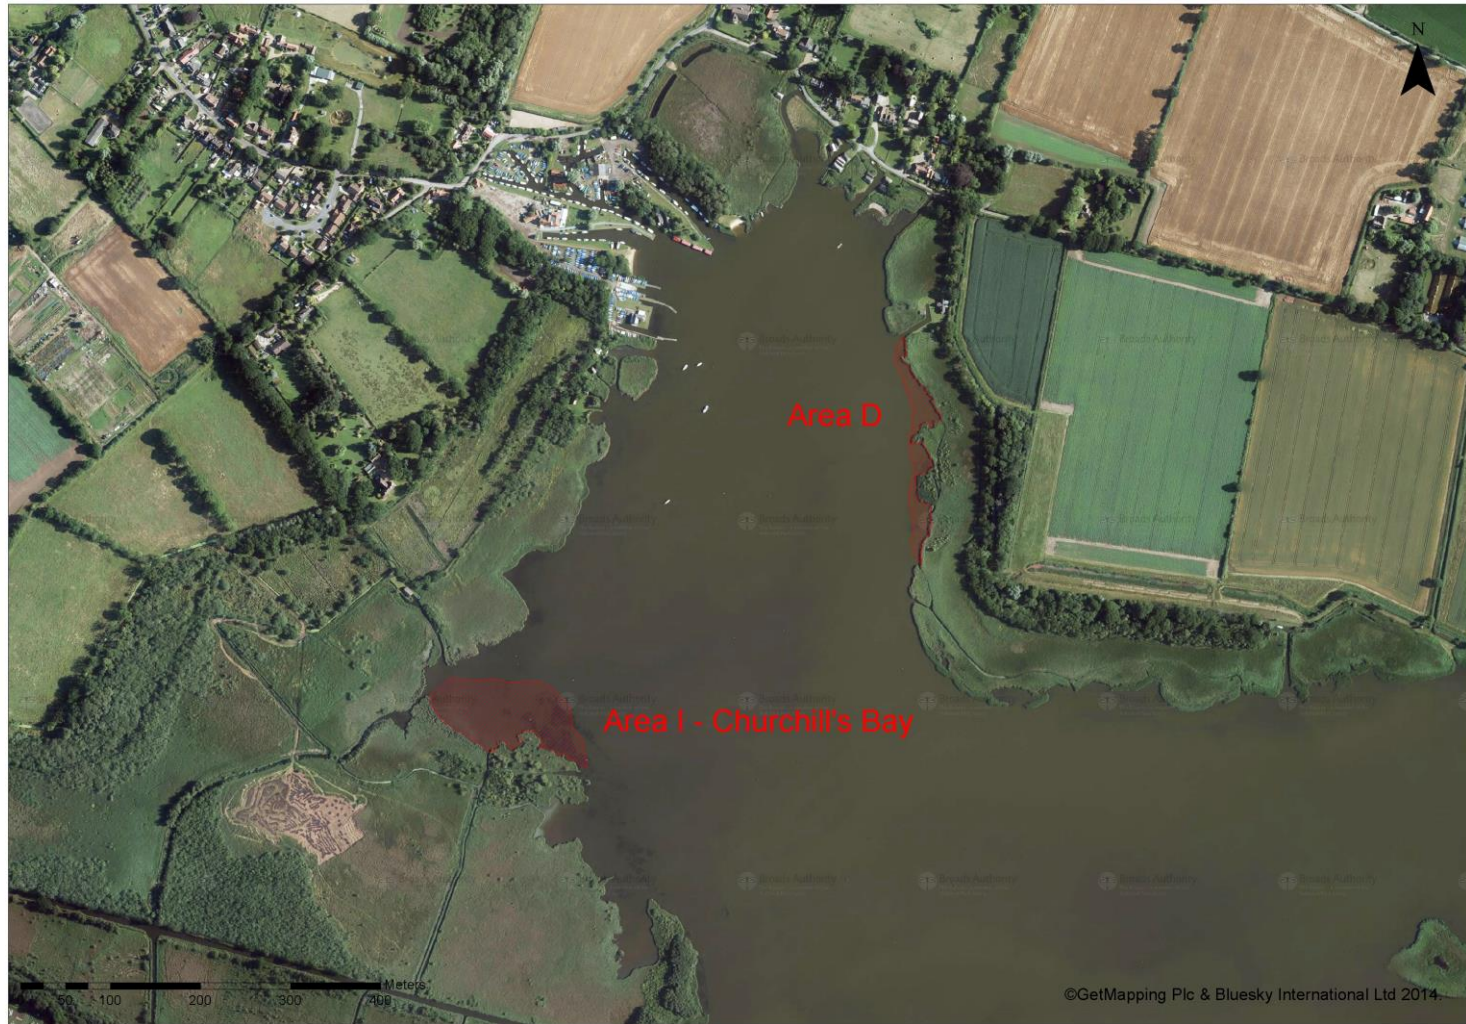
APPENDIX 2

Map showing favoured areas for reedbed enhancement

- Area I - on west side of the broad known as Churchill's Bay. A substantial area of reed swamp, around 10,500 m², been lost from this area since 1946. The edge of the reed growth is eroded with exposed root zones and little outward growth of reed into the open water. Again the underlying clay in this area is close to the surface, with a layer of recent sediment, mainly comprised of decaying reed and vegetative matter. The sediment is black and anoxic, supporting only a relatively small amount of water plants, including spiked water milfoil and some stoneworts.

5.9 Both sites are suitable for options that enhance reed bed area. They can receive some dredged sediment in the design and have firm clay beds that will enable construction of a low key, inexpensive retaining edge for the new reed bed area. If budget or time constraints allowed only one site to be worked on, the Site I, Churchill's Bay, would be the priority.
