**Construction, Maintenance and Environment Work Programme
Progress Update**

Report by Head of Construction, Maintenance and Environment

Summary: This report sets out the progress made in the delivery of the 2016/17 Construction, Maintenance and Environment Section work programme.

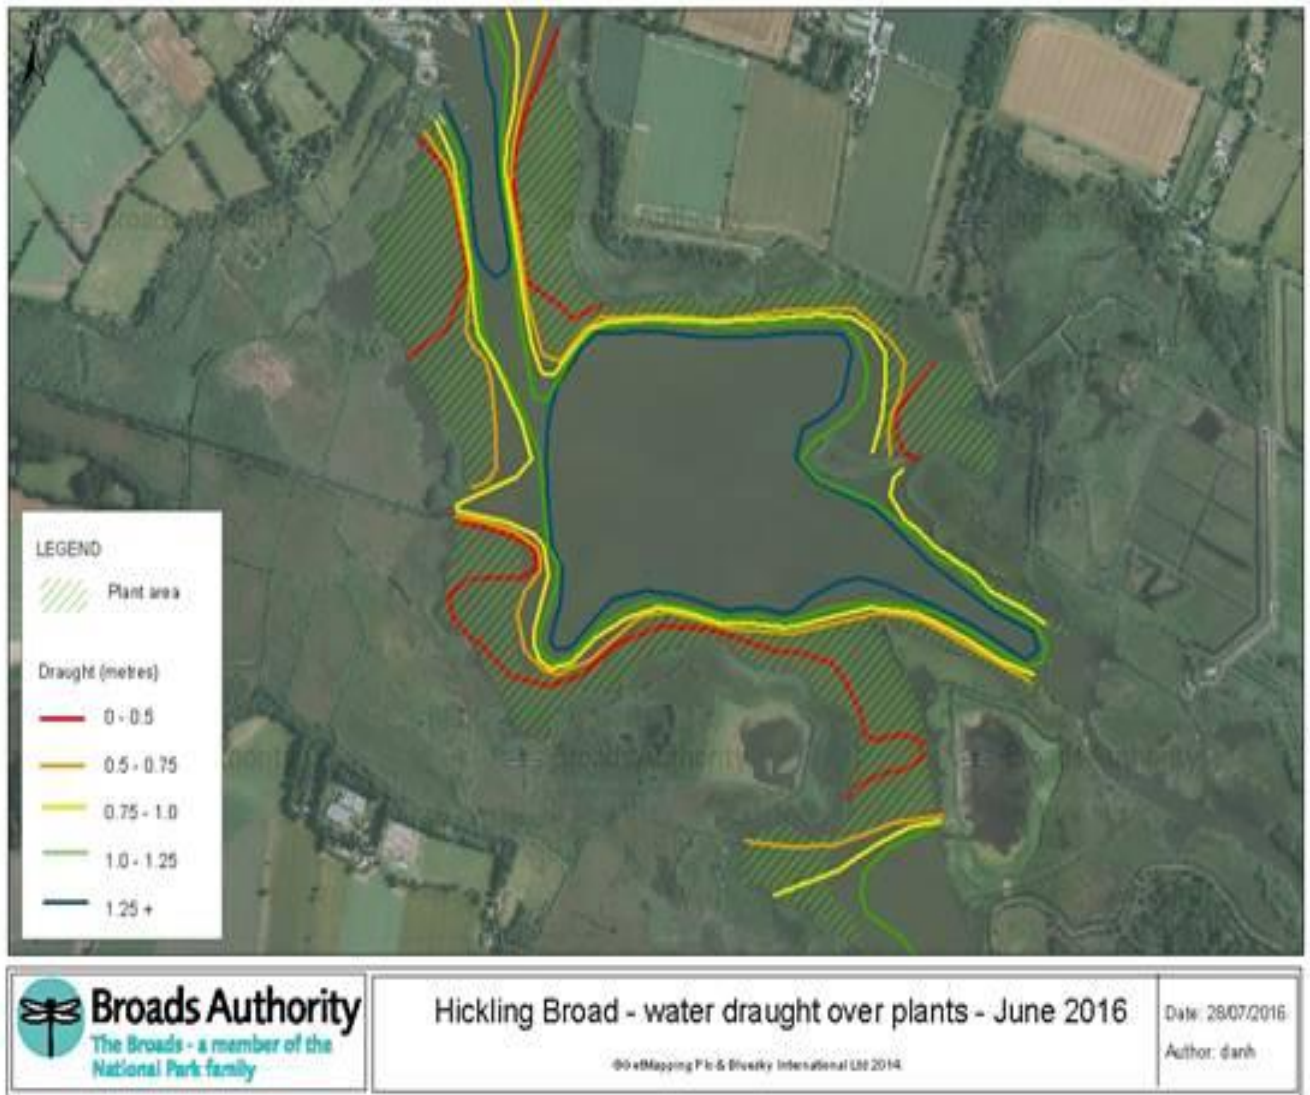
- 5.1 Hydro-acoustic (sonar) surveys of the broad in mid-June found that detectable plants only covered 17.4% of the whole broad bed – a relatively low amount for such a naturally plant-dominated shallow waterbody. The map below shows the area where plants were present as green hatchings and the water draught as depth contours. The surveys showed several areas where water plants were high and visible to the surface, but these were distinct and confined to areas north of Pleasure Island; on the western margins; and in the north bay.

Figure 1 - Map showing where plants were present as green hatchings and water draught as depth contours

- 5.2 There were also several patchy areas of less dense plants, but with tall (more than 50 cm) straggling growth. The tall plants were typically fennel-leaved pondweed and spiked water milfoil. It is these plant species that have caused issues with some keels and smaller engines getting fouled when travelling outside the marked channel. The Authority has shared this information with Hickling Broad Sailing Club and publically via the Broads Blog, to reach as many different users as possible and keep them up to date.
