Broads Authority

Cultural Heritage Survey Sheet

Norton Marshes Drainage Mill

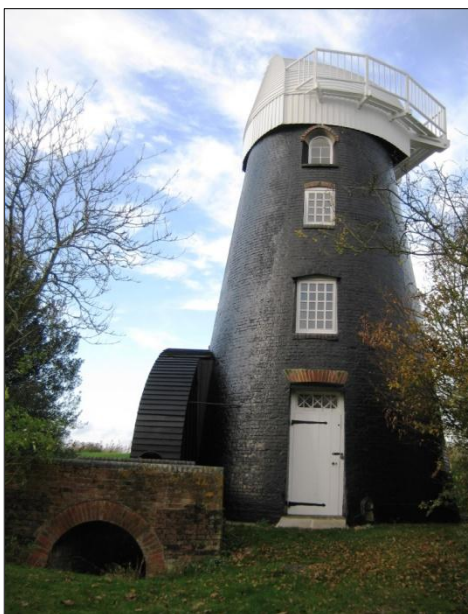
Cultural Heritage ID No: -	Inspection date(s): - Ben Hogg & Prue Smith 09/11/11	Location, Address and Grid Ref: -	
Listed Grade: - (N/L, N/PL) Local list	Fragility: - 1 (1 – 3)	Vulnerability: - 2 (1 – 3)	
Photographs: -IMG 4989 - 4996		BAR Risk Grade: - (A – F)	N@R
<p>Description/Context: - Drainage Mill. Tarred red brick tower mill. Small to medium size, 4 storeys with white painted boat shaped cap and gallery. Black stained horizontal boarded scoop wheel housing, small 20c single storey extension to riverside, also stained boarding on red brick plinth with red pantile roof. Part red brick drainage lane, possibly re-constructed. Ground floor timber boarded door with glazed light over on opposite side to river, 4 first floor windows, 2 windows to second and third floors, all timber with small panes. Third floor windows have arched heads. Converted to residential use. All in good condition. 20c red brick pump house nearby.</p> <p>A.C. Smith notes in 1989 that mill built in 1863, no internal machinery remains and that no wheel remains in reconstructed scoop wheel housing.</p>

<p>Significance: - A well restored example of a drainage mill in a prominent position beside the river Yare. The residential conversion has preserved the external character of the building.</p>			
<p>Threat posed: - No immediate threat.</p>			
<p>Conclusion / Recommendation: -</p> <p>Immediate:</p> <ul style="list-style-type: none"> • <p>Medium term</p> <ul style="list-style-type: none"> • <p>Long term:</p>
