Broads Authority

Cultural Heritage Survey Sheet

Randall's Mill, Calthorpe

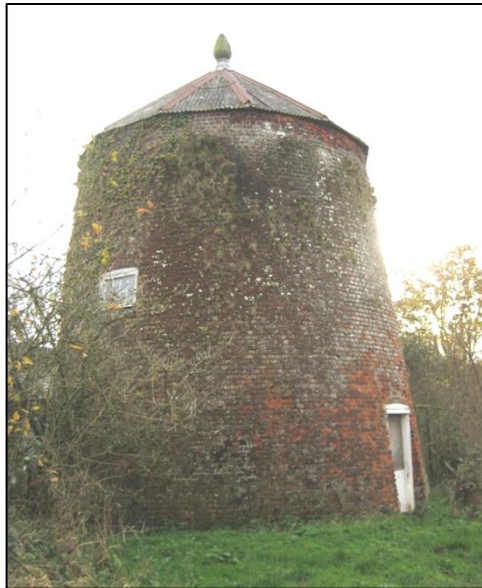
Cultural Heritage ID No: -	Inspection date(s): - Ben Hogg & Prue Smith 29/11/11	Location, Address and Grid Ref: -	
Listed Grade: - (N/L, N/PL) Local list	Fragility: - (1 – 3)	3	Vulnerability: - (1 – 3) 3
Photographs: -IMG 5045 - 5049		BAR Risk Grade: - (A – F)	N@R
Description/Context: - Substantial red brick tower mill, reduced to 3 storeys with conical corrugated iron roof and finial. Timber door and frame, two opposing timber first floor windows. Brickwork spalling with substantial vegetation growth. Adjoining brick shed/living accommodation not inspected. Drainage lane intact. Substantial remains of brick abutments, arches etc.			
Small modern brick pump house behind and 2 small wind turbines in field beyond.			
Significance: - the substantial remains of one of an important group of drainage mills in the Broads area and a feature in the landscape.			
Threat posed: - Potential continued erosion of brickwork and damage to brick from vegetation growth.

Conclusion / Recommendation: -			
Immediate: <ul style="list-style-type: none"> • 			
Medium term <ul style="list-style-type: none"> • 			
Long term:
