Broads Authority

Cultural Heritage Survey Sheet

Somerleyton Marshes Drainage Mill remains

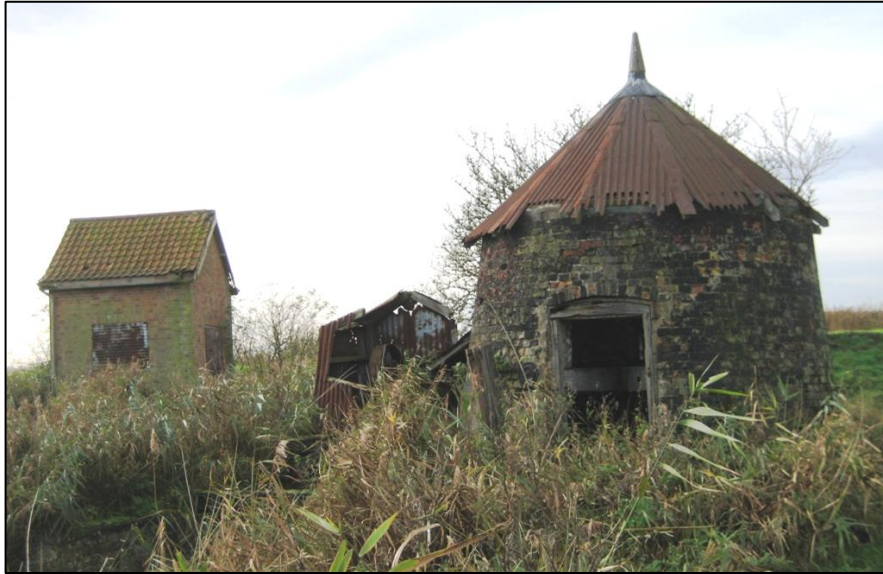
Cultural Heritage ID No: -	Inspection date(s): - Ben Hogg & Prue Smith 23/11/11	Location, Address and Grid Ref: -	
Listed Grade: - (N/L, N/PL) Local list	Fragility: - (1 – 3) 1	Vulnerability: - (1 – 3) 1	
Photographs: -IMG 5012 - 5023		BAR Risk Grade: - (A – F)	A
Description/Context: - Small formerly tarred red brick tower mill reduced to one storey with conical timber and corrugated iron roof in poor condition with lead pinnacle. Opposing doorways, that to riverside bricked up at base. Turbine survives in small corrugated iron pump shed adjacent to east, also in poor condition. Larger 20c brick and pantile electric pump shed between mill and river – possibly not in use. Door frame, but door missing. Very poor condition severe cracking to brickwork to north and east. Arch above south doorway and roof verge in poor condition.			
Significance: - the remains of one of an important group of drainage mills in the Broads area and a feature in the landscape.

Threat posed: - Vegetation growth and brickwork decay. Water ingress through filing roof, doors missing.			
Conclusion / Recommendation: -			
<p>Immediate:</p> <ul style="list-style-type: none"> • <p>Medium term</p> <ul style="list-style-type: none"> • <p>Long term:</p>
