Broads Authority

Cultural Heritage Survey Sheet

Engine House, Strumpshaw

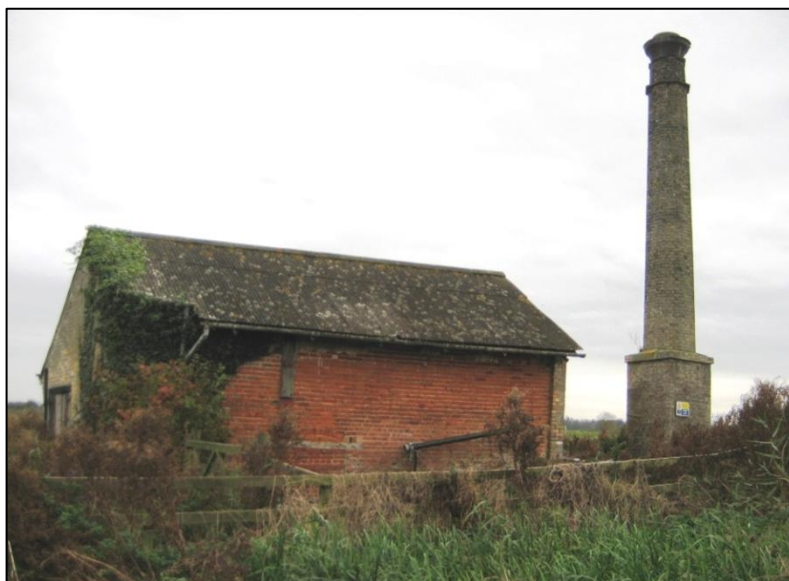
| Description/Context: - Single storey engine house, corrugated asbestos sheeting roof with gault (white) brick to north, east and south, soft red brick to west side. Two semi-circular headed windows to river side (south) with remains of c.i. frames indicating small panes, later offset double timber doors to north elevation. Decorative 'tudor rose' patress plates to front and rear. Closed openings at lower level to south and east. Adjacent on riverside, tall octagonal gault brick chimney on square base with cast iron string course and circular c. i. cap. Cracking to brickwork, ivy growth extends to roof on north west corner. Some earlier b'work repairs in Fletton bricks, some spalling and open joints to w redbrick elevation. | | | |
| Threat posed: - Lean to chimney. Vegetation growth, structural instability. | | | |
