Broads Authority

Cultural Heritage Survey Sheet

Palmers Mill, Upton Marshes

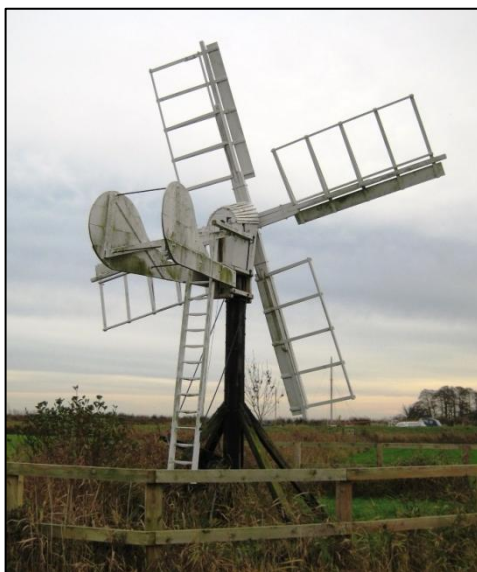
| <p>Description/Context: - Hollow post mill, restored to working order. Four single-shuttered spring sails, small boarded buck (on top of main post), twin tail vanes and ladder, all white painted timber. Main post 11” x 10” section, approximately 12ft high and quarter bars, all black tarred timber on sunk piers. Iron piston and 10” inside diameter cylinder. In good condition, but could do with decorating in the near future. Removed when derelict from original site near Acle in 1976 and restored on present site 1978-79 by Richard Seago. First pumped water 9 July 1980.</p> | | | |
| <p>Threat posed: - No immediate threat.</p> | | | |

| <p>Conclusion / Recommendation: -</p> <p>Immediate:</p> <ul style="list-style-type: none"> • <p>Medium term</p> <ul style="list-style-type: none"> • <p>Long term:</p> | | | |
