Broads Authority

Cultural Heritage Survey Sheet

Buckenham Ferry Drainage Mill

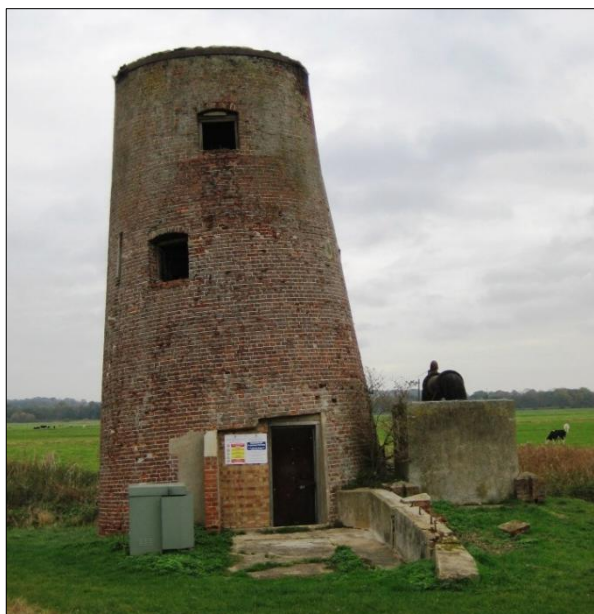
Cultural Heritage ID No: -	Inspection date(s): - Ben Hogg & Prue Smith 09/11/11	Location, Address and Grid Ref: -	
Listed Grade: - (N/L, N/PL) Local list	Fragility: - 1 (1 – 3)	Vulnerability: - 2 (1 – 3)	
Photographs: -IMG 4966 - 4970		BAR Risk Grade: - (A – F)	N@R
Description/Context: - Red brick (formerly tarred) tower drainage mill shell, medium size, 4 storeys, leaning and 'kinked' near top indicating movement pre-dated later raising. Kerb intact. Partial timber and concrete flat roof. Window openings at first, second & third floor, no joinery. 20c steel door in enlarged opening partly closed with Fletton bricks. Modern machinery internally, and possibly remains of original floors. Rendered pump enclosure and electrical equipment nearby. Some remains of drainage lanes. Some brickwork spalling and open joints, pigeon infestation. Lack of roof covering an issue.			
Significance: - the substantial remains of one of a group of drainage mills in the Broads area and a feature in the landscape.

Threat posed: - No immediate threat, but lack of roof covering will lead to long term damage. Bird ingress an issue.			
Conclusion / Recommendation: -			
<p>Immediate:</p> <ul style="list-style-type: none"> • <p>Medium term</p> <ul style="list-style-type: none"> • <p>Long term:</p>
