Peat Cameras: Land Subsidence and Watertable Assessment

Introduction

Peat cameras

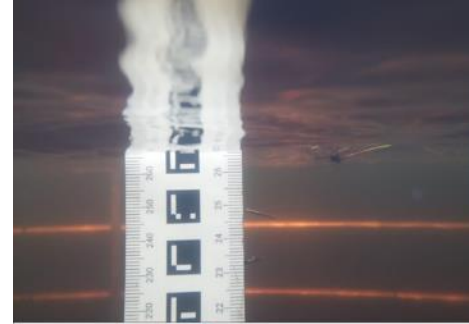
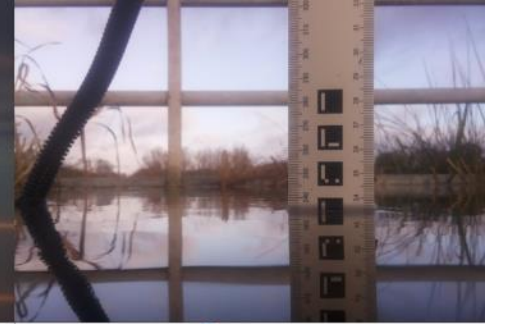
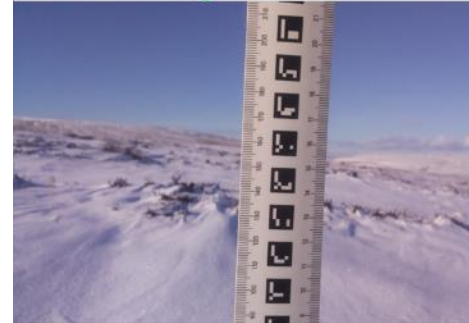
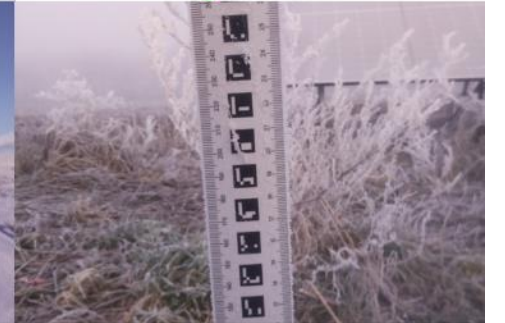
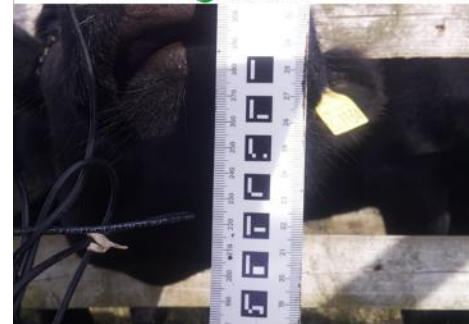
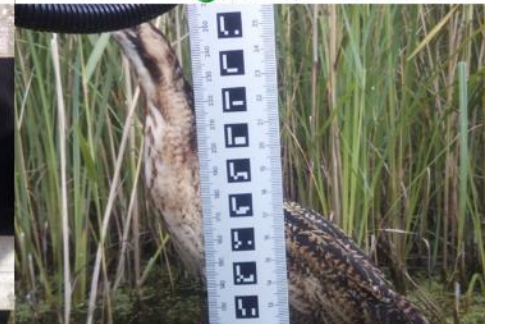
Site: PeatCam_035 UK Centre for Ecology & Hydrology 29/10/2023 12:00:50

Site: PeatCam_034 UK Centre for Ecology & Hydrology 25/11/2023 14:00:45

Site: PeatCam_004 UK Centre for Ecology & Hydrology 10/03/2023 16:00:40

Site: PeatCam_012 UK Centre for Ecology & Hydrology 22/01/2023 10:00:52

Site: PeatCam_016 UK Centre for Ecology & Hydrology 09/10/2023 10:00:50

Site: PeatCam_030 UK Centre for Ecology & Hydrology 26/08/2023 12:00:44

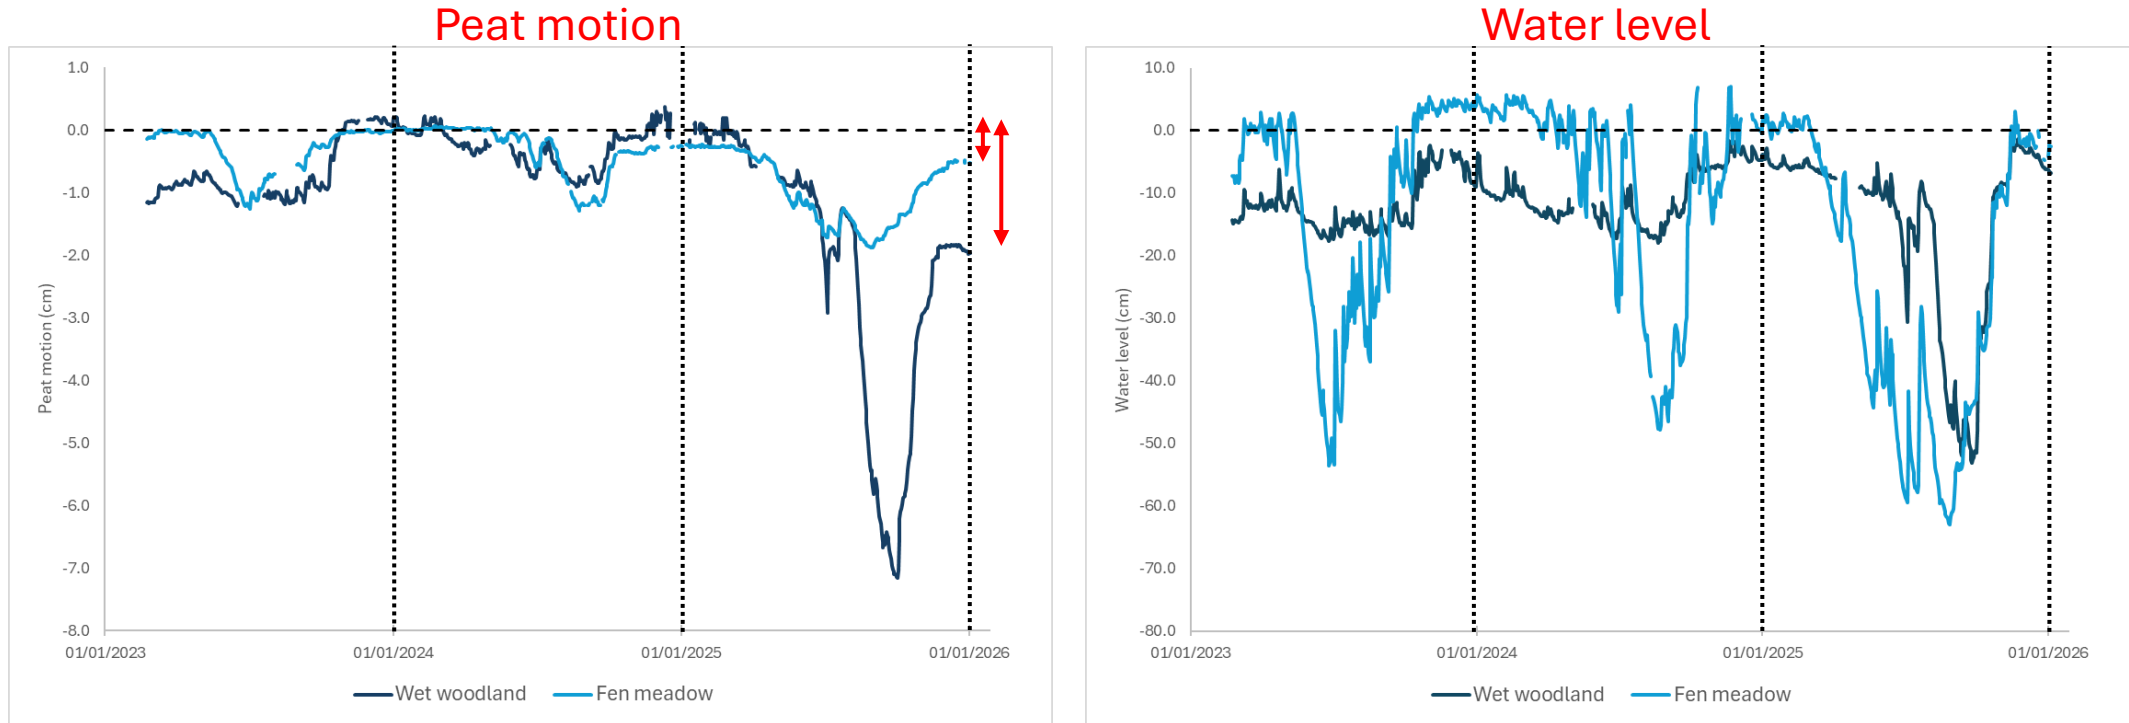
Semi-natural sites: How Hill

- Water level and peat motion very stable during 2023 and 2024
 - WL at the Fen meadow showed larger variation through the year/s with just a few mm of peat subsidence
 - Wet woodland site didn't have any apparent subsidence (WL did not drop during the summer months)
- Drought in 2025 has resulted in a peat loss of 2 cm at the wet woodland site while the fen meadow showed a similar peat loss than that recorded in 2024.
 - In the long-term, continuous peat loss (through oxidation or compaction) will increase the flooding risk of these areas

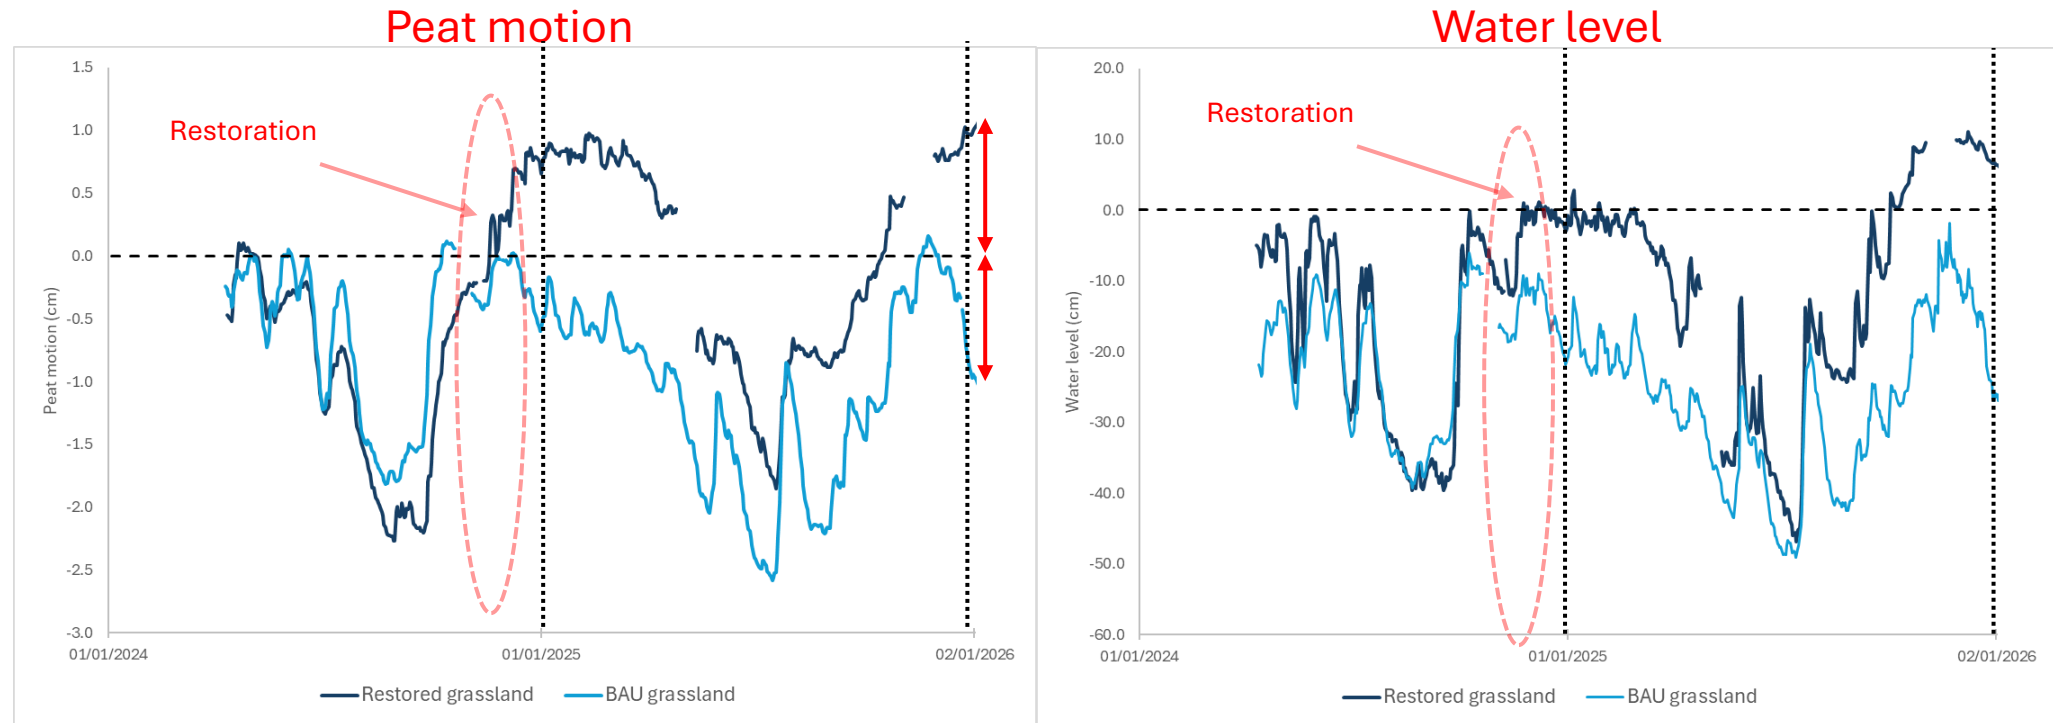
Grassland land use in the Broads

- Two grazing farms (500-800m apart) adjacent to the river Yare. One site was restored in November 2024.
- Before restoration, WL and peat motion was similar at both sites
- After the restoration, both, WL and WT have raised considerably.
- While the 2025 drought has resulted in a peat loss of 1 cm at the BAU site, the restored site does not show any apparent peat subsidence. Restored site has increased resilience against drier conditions.

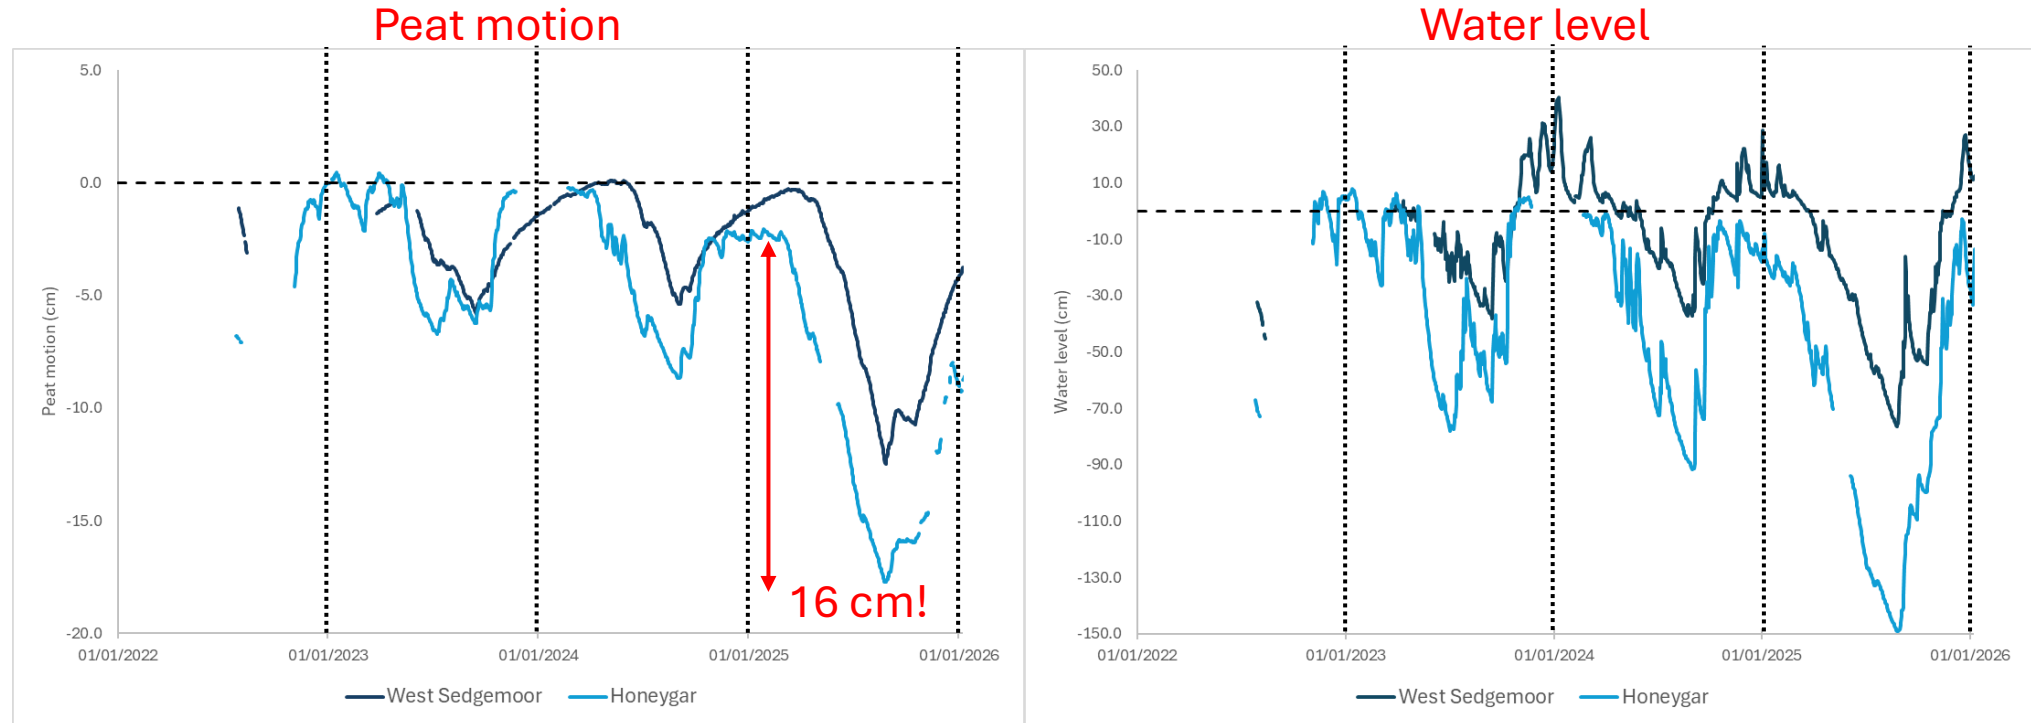
Grassland land use in the Somerset Levels

- Large seasonal peat motion at the grassland sites in the Somerset Levels
- West Sedgemoor, has great resilience and the large peat motion recorded annually did not result in any apparent peat subsidence between 2023 and 2024. However, in 2025 → around 3 cm of peat.
- By contrast, peat at Honeygar seems more susceptible to changes in water level, with around 2 and 10 cm of peat loss measured in 2024 and 2025, respectively.
- Wet conditions at West Sedgemoor during the winter resulted in less peat loss during the summer.

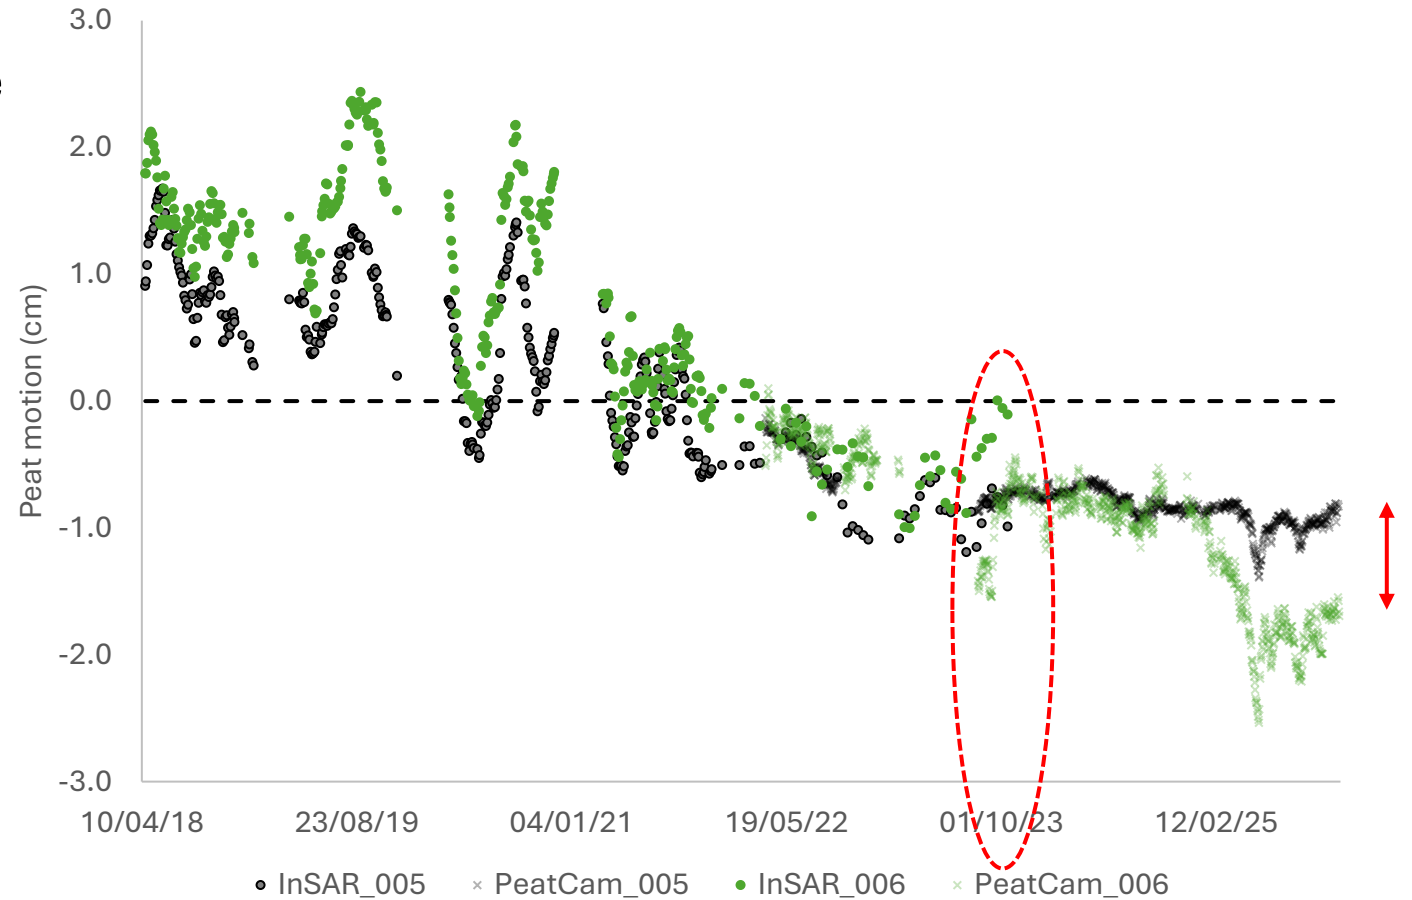
Blanket bogs (North Pennines)

- Can we detect the success of peatland restoration using remote sensing techniques and peat cameras?
- Before the restoration, no clear differences in peat subsidence between both sites
- Site #005 was restored in the autumn of 2023
- Restored site was able to retain more water and minimise peat subsidence during the 2025 drought
- Good agreement between InSAR and in-situ measurements

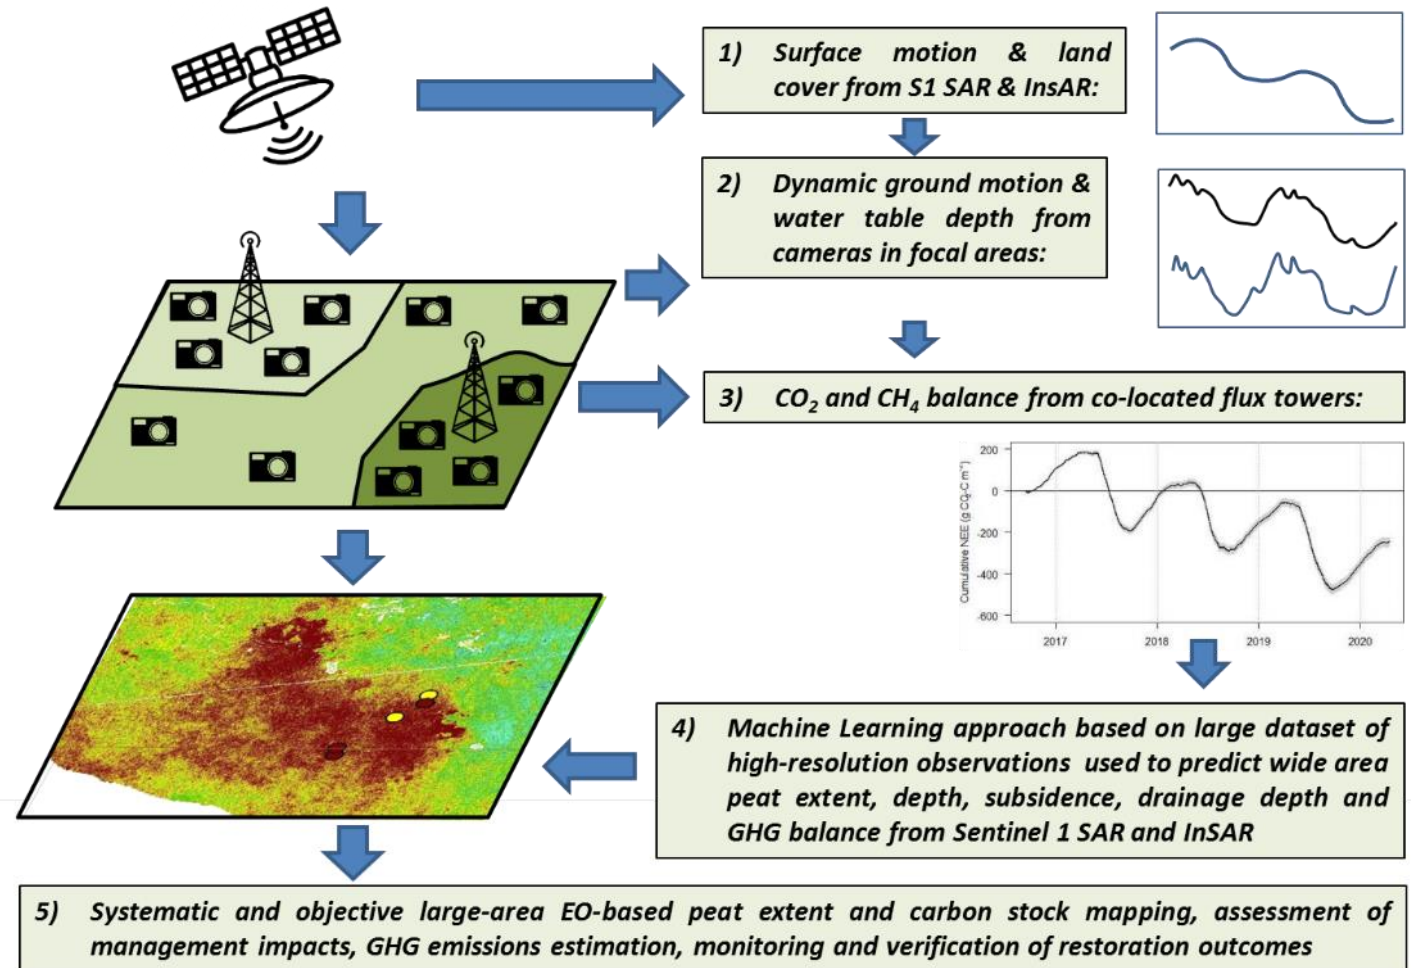
New peatland monitoring, reporting and verification (MRV) concept

- A new standard for global peatland monitoring and reporting
- Combination of in-situ peat subsidence and InSAR estimates
- Linking peat motion to GHG emissions
 - Development of empirical “transfer functions” between satellite data and ground observations of peat motion, water table depth, CO₂ and CH₄ emissions
- Scaling up to regional and national level using machine learning and other Earth Observation techniques
