**Enforcement of planning control  
Non-compliance with planning condition at  
Barnes Brinkcraft, Riverside Estate, Hoveton**  
Report by Head of Planning

**Location:** Barnes Brinkcraft, Riverside Road, Hoveton

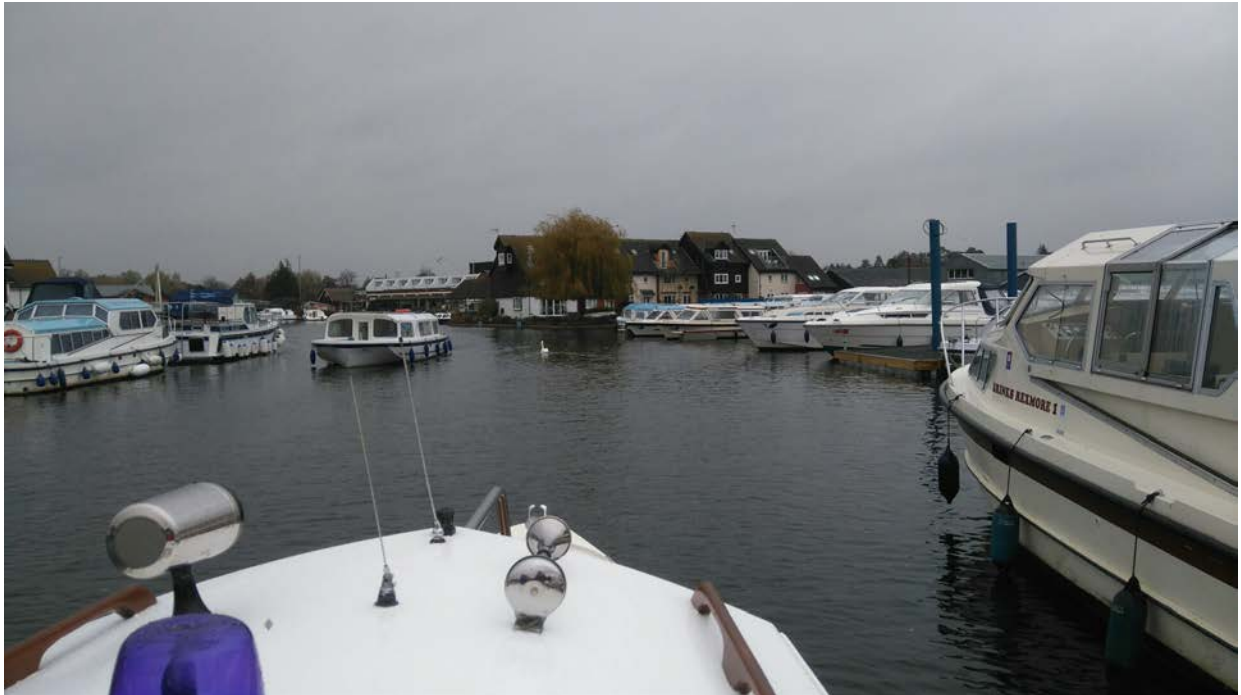
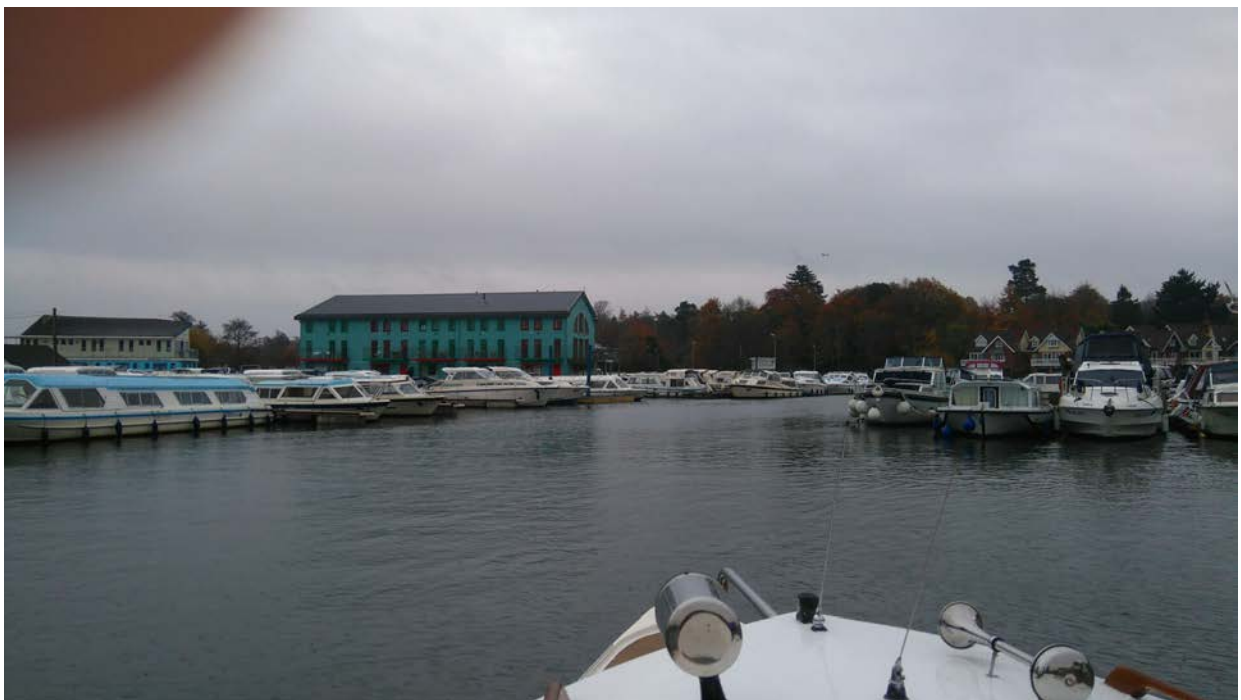
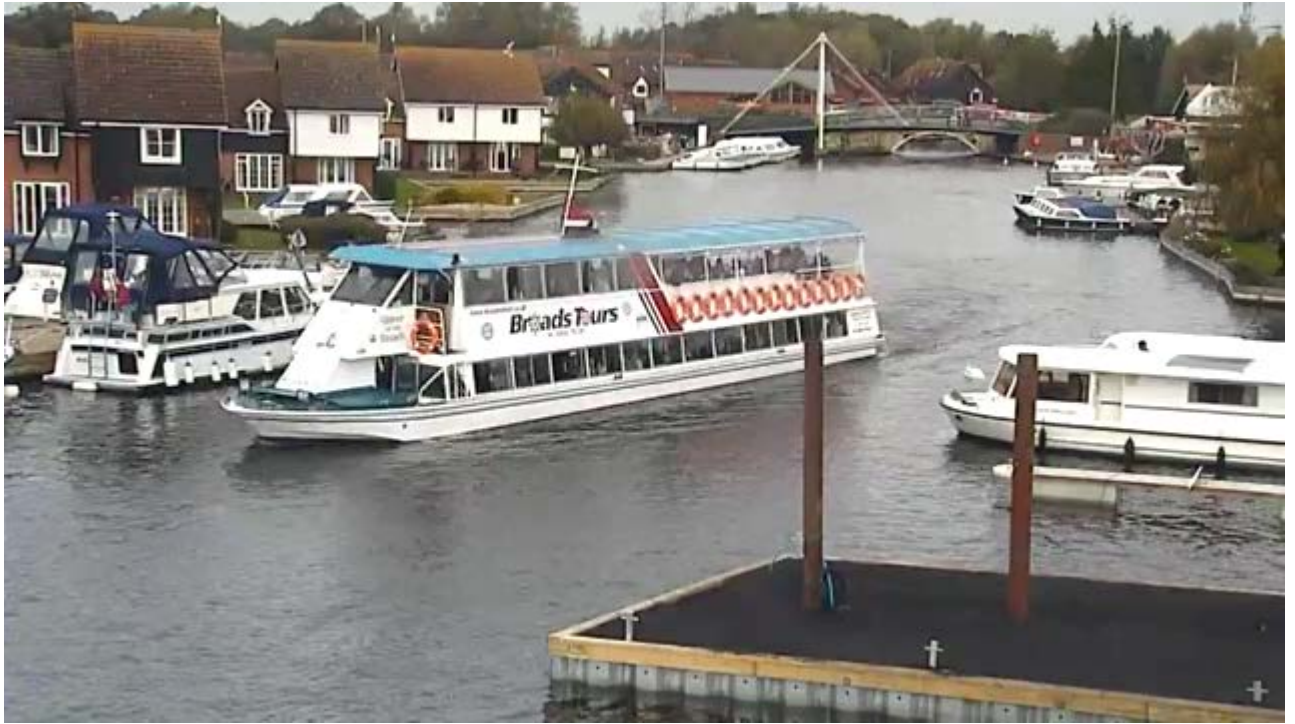
## APPENDIX 2

- 2.1 The works to implement the planning permission commenced in September 2017, initially with the clearance of the basin, the removal of the peninsula of land and the renewal of the quay heading. The works have not, however, been completed in accordance with the planning permission as follows:
- a. A spit of land downstream of the basin, which runs perpendicular to the river and separates this mooring basin from another mooring basin, has been extended out into the river by approximately 1.2m; and
  - b. The new pontoon has been located approximately 4.2m closer to the river than proposed on the approved drawing; and
  - c. The configuration of the moorings on the new pontoon is not as shown on the approved drawing.

These are illustrated by the photographs in Appendix 2

- 2.2 The operator has explained in respect of (a) that the land has been restored to a previously existing extent, the former land having been removed at some point in the past by a previous owner. In respect of the pontoon at (b), it should be noted that it is 0.5m narrower than permitted and that the approved drawing shows the guide piles located to the front (riverside) of the pontoon, whilst on site they are located to the rear.

- 2.3 The cumulative effect of the above changes is that the navigation channel has been narrowed, both by the encroachment of the extended land and the encroachment effect of vessels mooring on the new pontoon. The extent of the encroachment by moored vessels will depend on their length, however as the pontoon is approximately 3.7m further forward (taking account of its reduced width) than previously shown, there remains potential for encroachment by vessels of an average length. It should be noted that initially vessels of up to 10.5m in length were being moored on the new pontoon, but when advised of the issues the operator moved these and limited the length to 7.5m.

- 5.1 While the Authority welcomes the continued investment in the site by one of the largest hire boat operators, the encroachment of this unauthorised development into the navigation area is deemed unacceptable. It is recommended that the Planning Committee authorises officers to negotiate the restriction on the vessel length, an agreed mooring configuration, a scheme of management in respect of the pontoon, and the removal of the build-out.
