Navigation Committee

Water Plant Management

Report by Head of Construction, Maintenance & Ecology

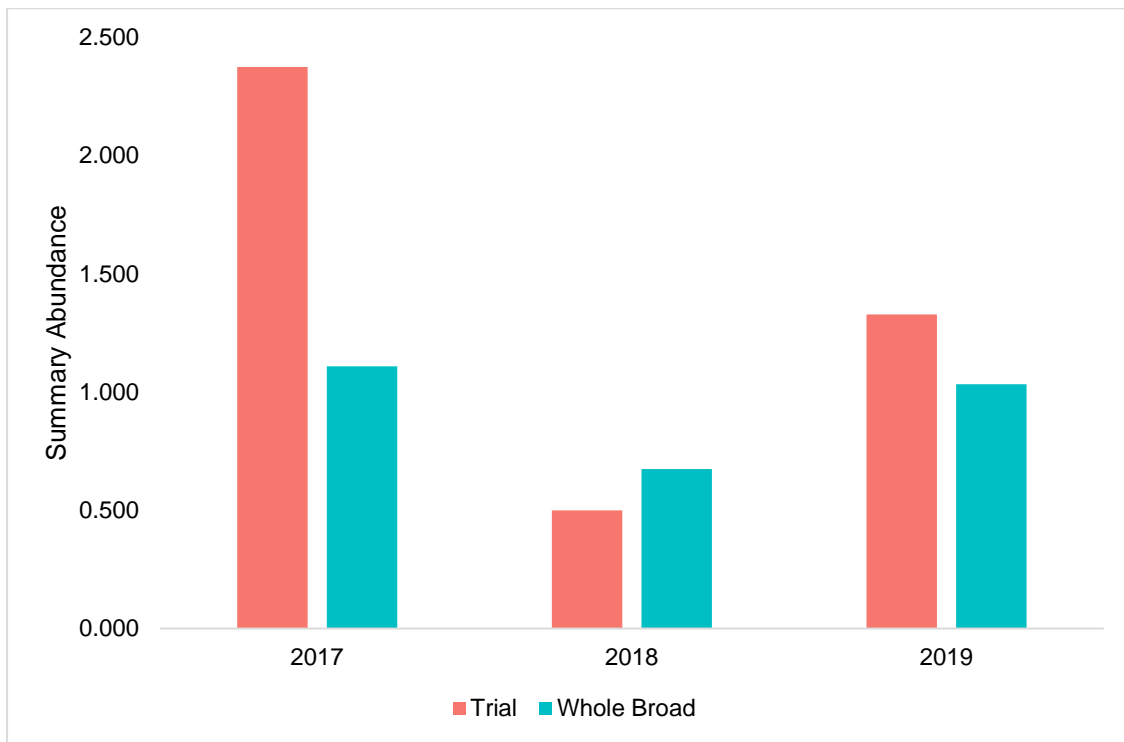
Figure 9: Abundance of intermediate stonewort in the treatment plots (red bars) and the whole broad survey (green bars)

Figure 9 shows the variation over the monitoring period of intermediate stonewort, which has the scientific name *Chara intermedia*. *Chara intermedia* was initially the dominant stonewort species present in the experimental cutting area. The method used to quantify plant abundance was the same as used in the routine Broads annual water plant survey. In 2017 *Chara intermedia* had a greater abundance in the experimental cutting area compared to the whole of the broad. This is perhaps unsurprising, as the broad encompasses many different areas of mixed species, bare sediment areas and sample points within the marked channel. The experimental cutting was focussed within a large and contiguous stonewort bed.

However, by 2018 a significant drop in the abundance of *Chara intermedia* was observed in the treatment plots. This was mirrored by a similar trend across the broad a whole. Whilst the abundance of *Chara intermedia* increased again in 2019 in the treatment plots, it was still less abundant compared to 2017 (Figure 9). Given the similar patterns in the abundance of *Chara intermedia* over the three years, it would suggest that 2018 was generally a poorer year for *Chara intermedia* across the whole broad and not just in the treatment plots.
