Breydon Water Navigation Works
Report by the River Engineer

Author: Tom Hunter
Date of report: 26 November 2013

TURNTIDE JETTY STRUCTURAL CONDITION SURVEY AND RECOMMENDATIONS

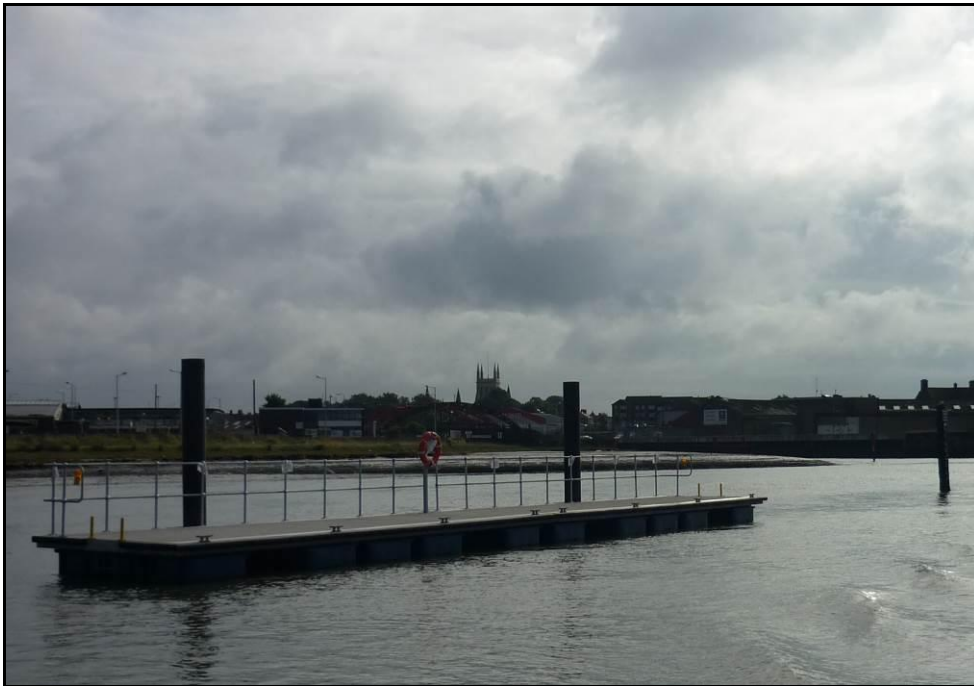
Photo 2: New Layby mooring pontoon

- 2.2.3 Since installation Trinity House, during a routine inspection, requested that the pontoons be lit with appropriate navigation lights.

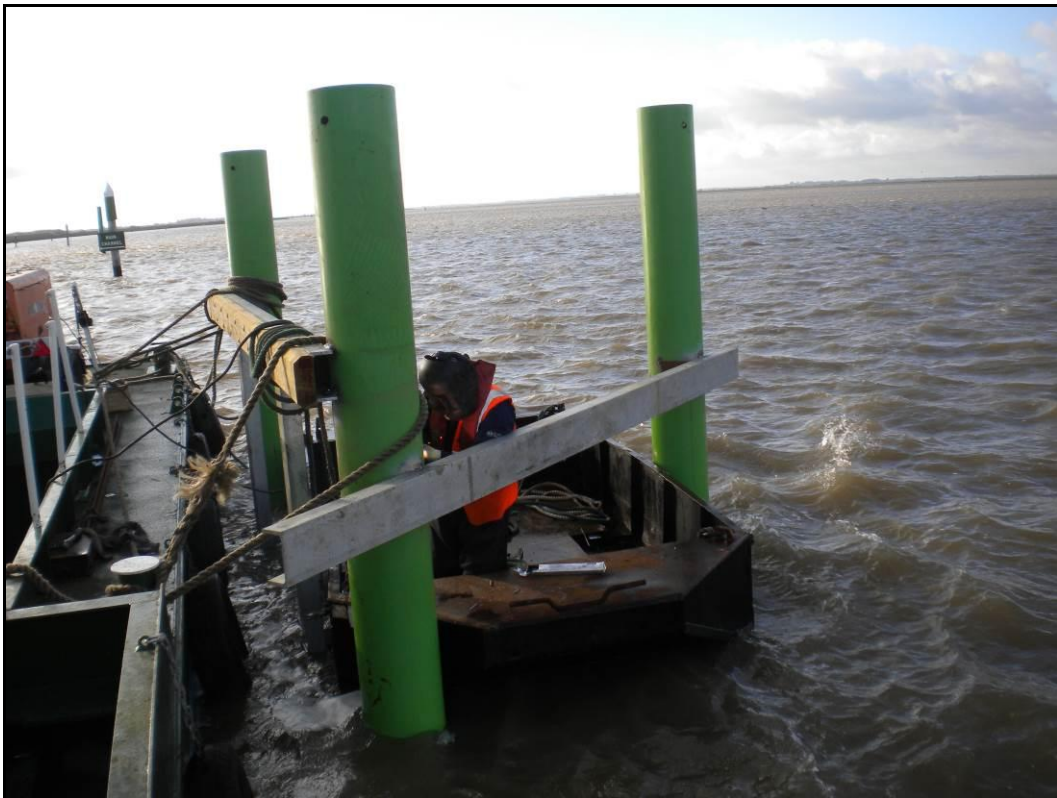
Photo 3: New de-masting dolphin during construction

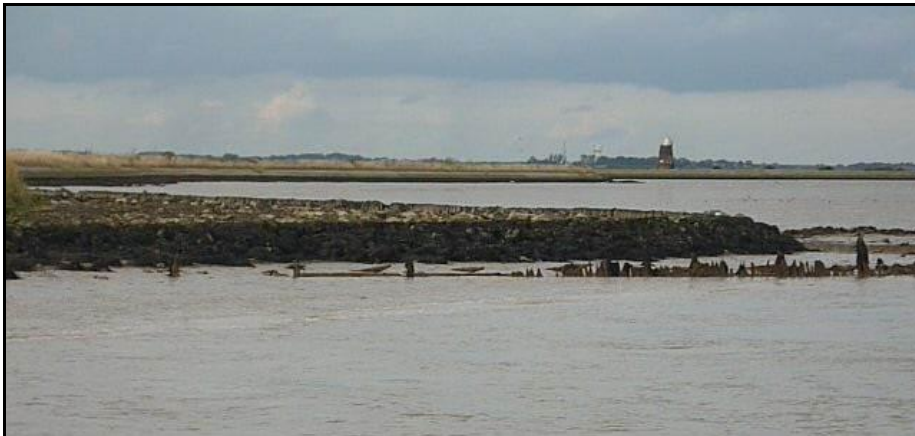
Photo 4: Dickey Works at low tide

- 4.3 Even on a low spring tide little of the remaining structure of the Dickey Works is visible and therefore the extent of the survey was limited. To draw firm conclusions it may be necessary to undertake a sonar survey beneath the waterline. This will provide better detail on the extent of the remaining structure and navigation hazard posed.
- 4.4 At present the structural remains are marked, but removal is considered appropriate. A trial will be undertaken to pull some of the piles to establish the feasibility of mechanical removal and confirm the extent other services such as divers will be required.

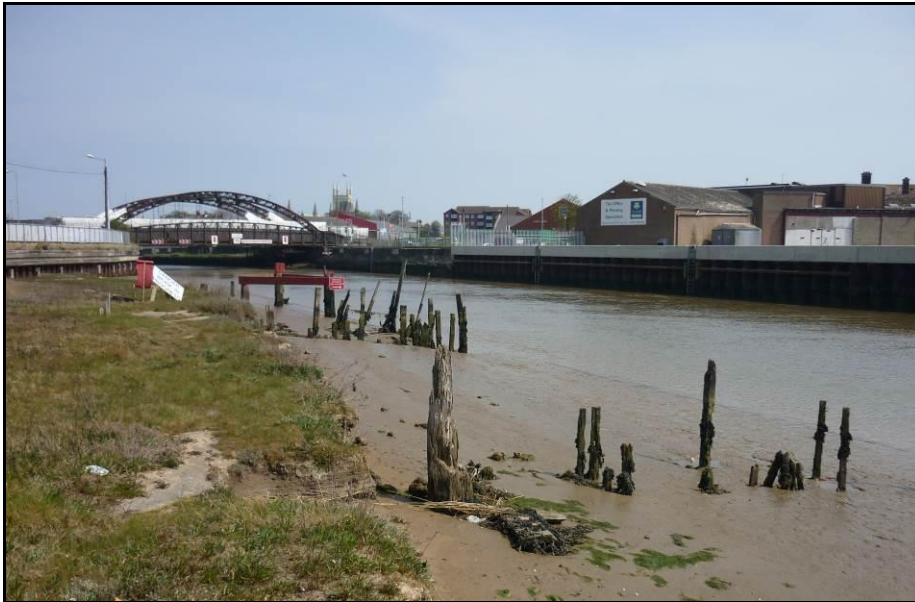
- 5.1 Throughout Breydon Water and the River Bure channel there are a variety of known submerged hazards. Most of these are outside of the channel and either sunken vessels or remains of old piling. However there were remains of timber piled structures at Bure Mouth which were very close to the channel.

Photo 5: Piling remains now removed from Bure Mouth

- 5.2 During the summer the Authority took the opportunity to use a local contractor to remove these piles, whilst the Construction and Maintenance team mobilised to remove a degraded dolphin structure from the River Bure just upstream of Acle New Road Bridge.

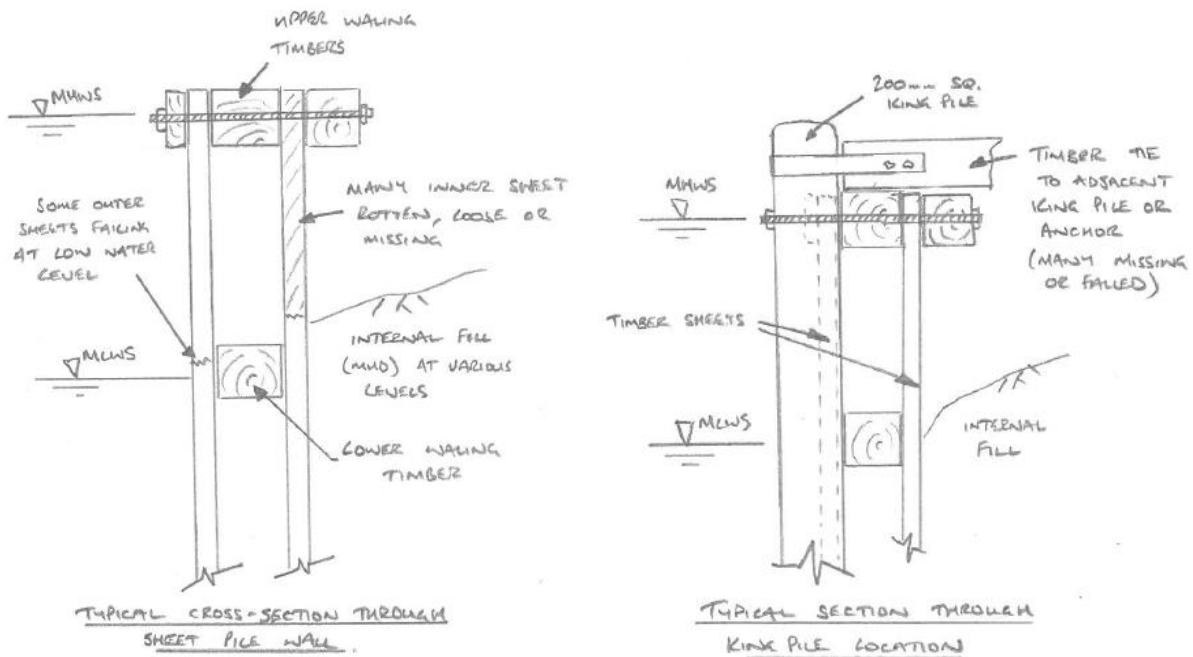
Essentially the structure is an anchored timber sheet piled structure. The structure relies on cantilever strong points provided by 200mm square timber king and anchor piles. Typical cross-sections are shown below.

Much of the structure remains in place and therefore continues to function as a training structure to the hydraulic flows. However, with the exception of the return at the west end, the general condition of the structure is poor. Many elements, particularly on the erosive River Yare side, have failed or are failing. This is leading to localised loss of fill and progressive collapse of the sheet piled frontage.
