Navigation Committee 10 December 2015 Agenda Item No 12

Broadland Flood Alleviation Project: Planning Application for Piling Removal Works and the Installation of Erosion Protection in Compartment 37 (Upton Dyke)

Report by Senior Waterways and Recreation Officer

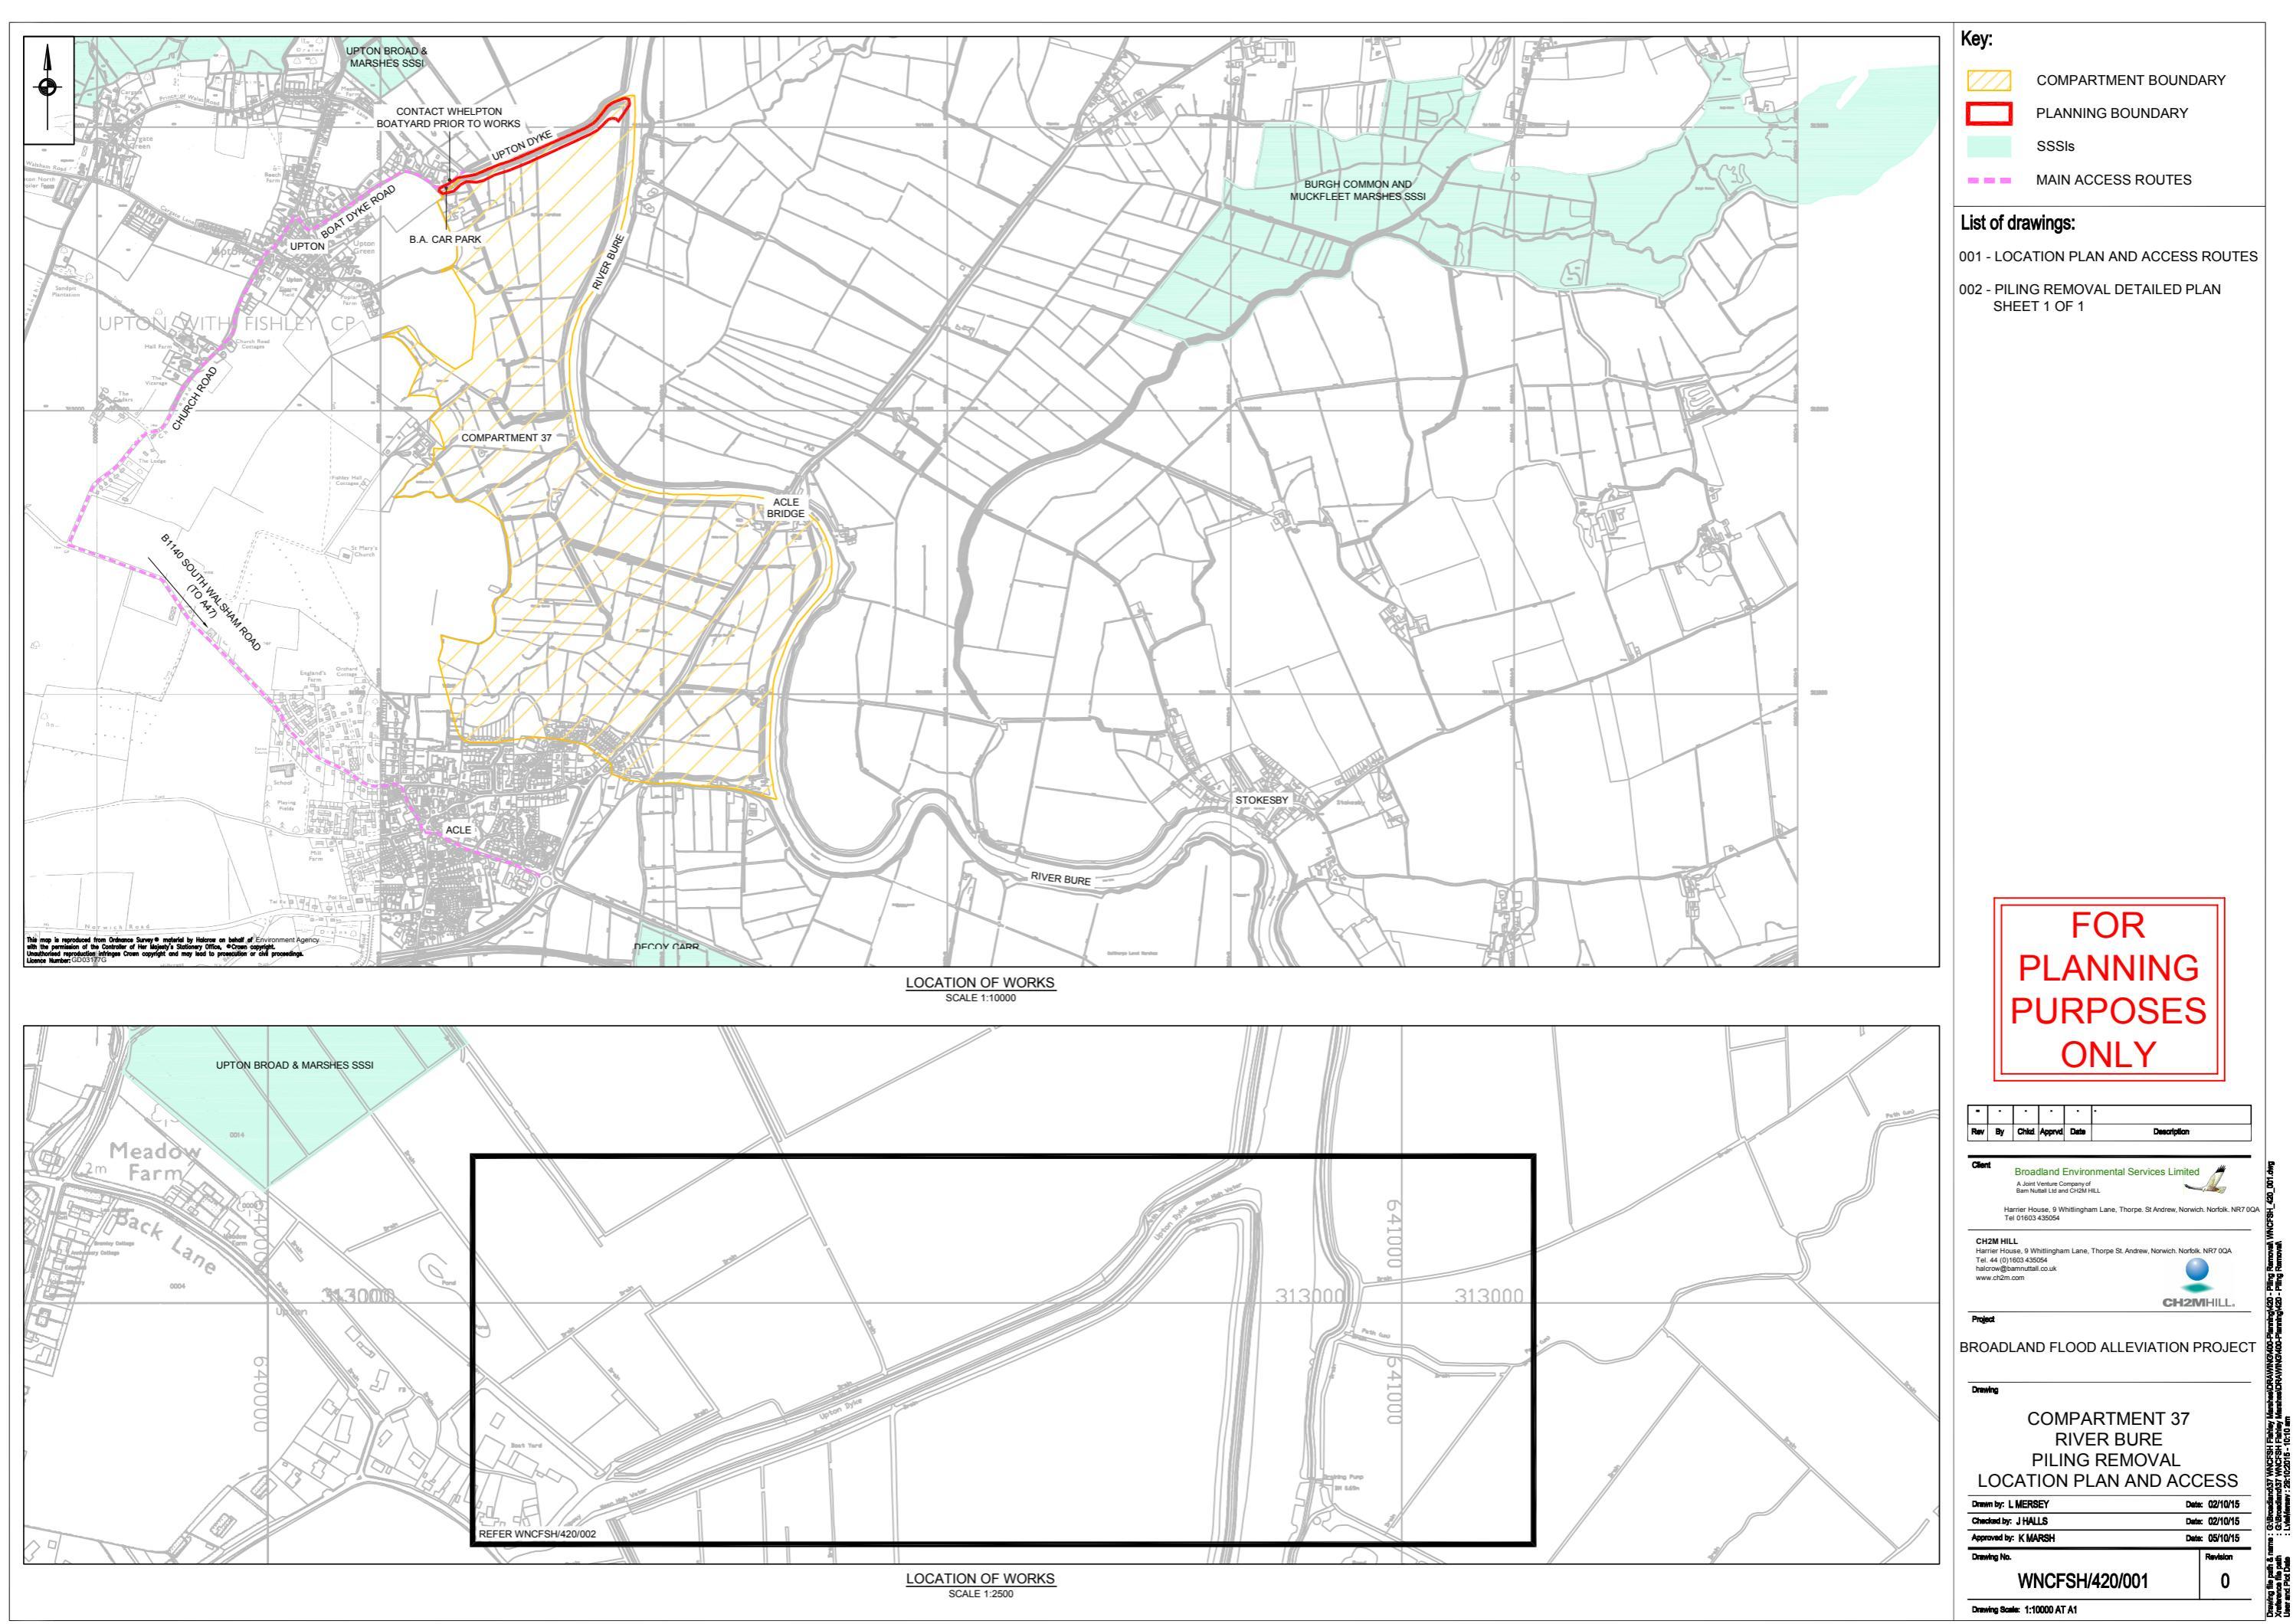
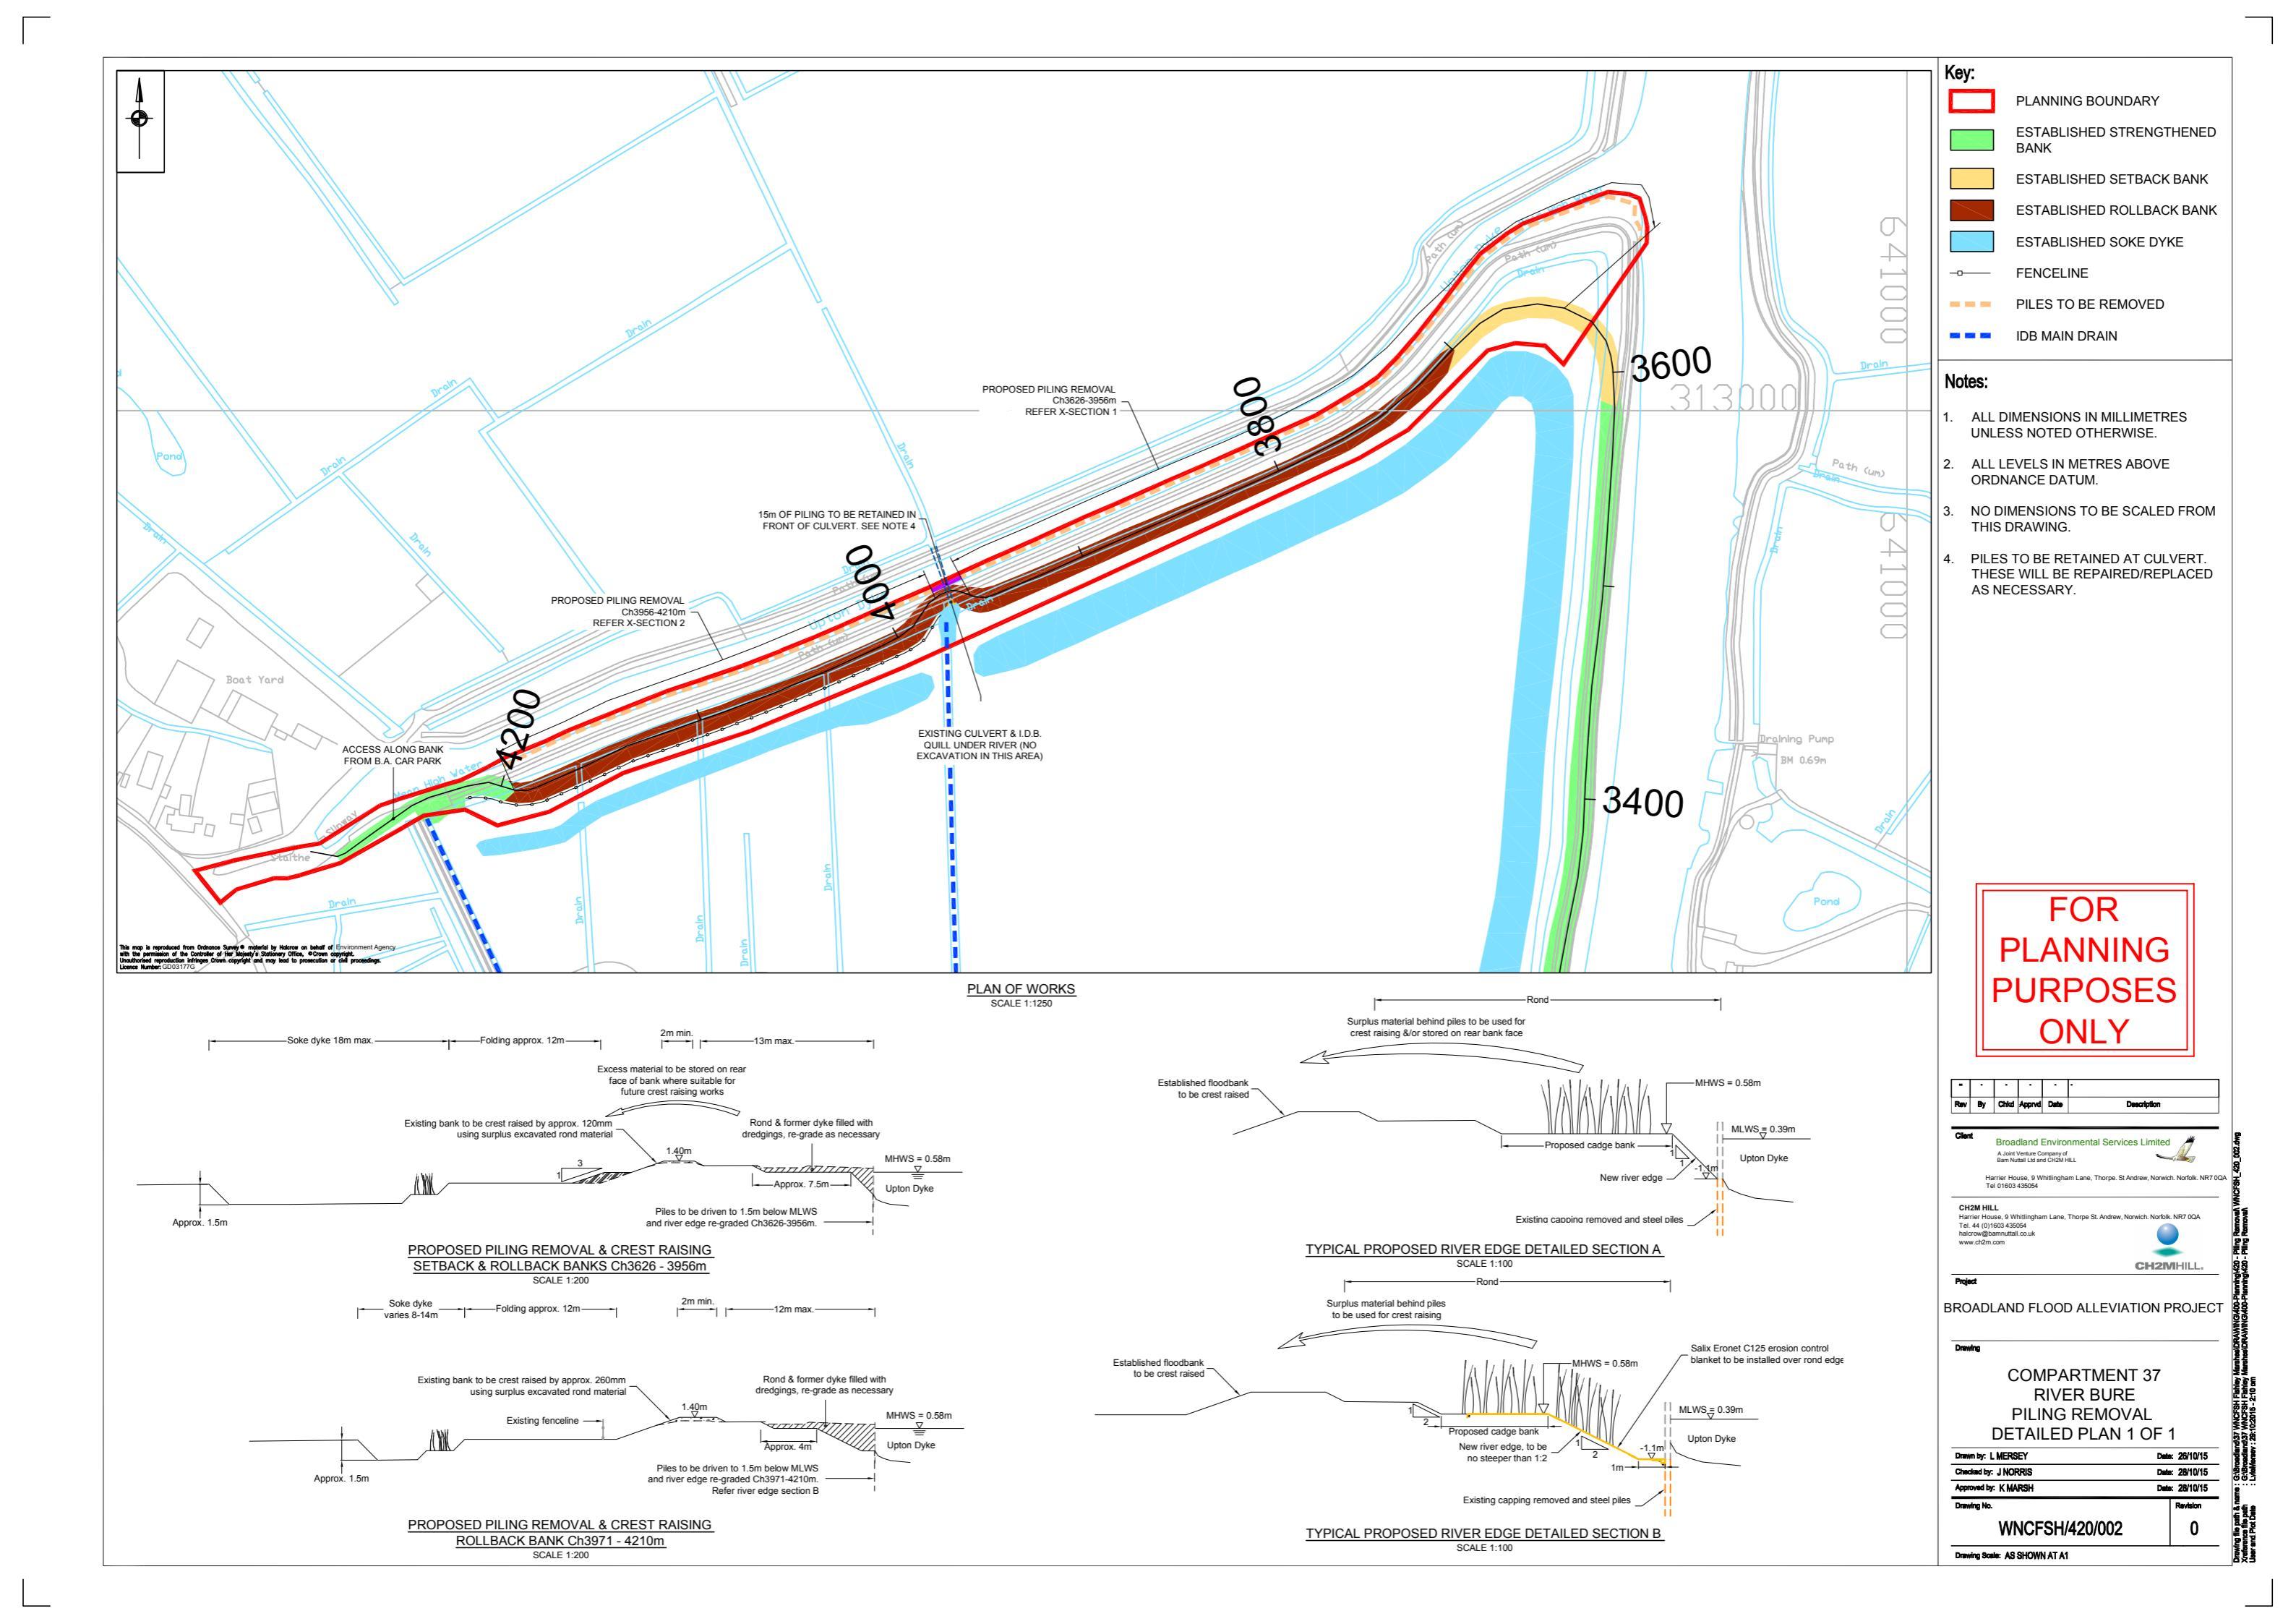
| Background papers: | Nil |
|---|--|
| Appendices: | APPENDIX 1 – Compartment 37 detailed maps. |

- 2.1 As mentioned in paragraph 1.2 above the only piling identified for removal in the planning application is in Upton Dyke. The location of these works and the detailed cross sections of the proposals are shown on the plans at Appendix 1.
- 2.2 BESL has surveyed the piling in the dyke and assessed that it is in poor condition and likely to deteriorate further to the extent that it would become a potential hazard to navigation. The Broads Authority has also recently surveyed the piling and reached the same conclusions.
- 2.3 BESL is proposing to remove approximately 584m of piling on the right hand bank of the dyke and reprofile the bank to encourage reed growth. The normal approach taken to dealing with the removal of piling is to extract the

2.4 In this application BESL is also proposing to install erosion protection in the form of a coir (coconut fibre) blanket along a 239m length of the bank after it has been reprofiled. This design is shown in detail on the plans at Appendix 1.

piles from the river bed and to reprofile the bank from the toe of the pile line. In this case, however, BESL is proposing to drive the piles into the bed of the dyke to a depth below the dredge specification for the dyke so that they do not create a navigation hazard. Should the piles fail to drive successfully they will be extracted from the bed in line with BESLs usual methodology for piling removal. This approach was adopted successfully in Compartment 22 on the River Chet and does give greater stability for the reprofiled bank than the usual method of extracting the piles. The depth the piles would be driven to would be agreed with officers and a sonar survey undertaken after the works to ensure that no remnant piles or other hazards remain on the bed of the dyke.
