Broads Authority

Cultural Heritage Survey Sheet

Clayrack Windpump, How Hill, Ludham

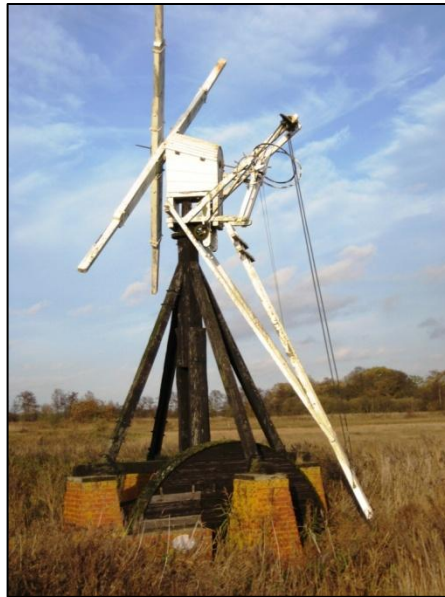
Cultural Heritage ID No: -	Inspection date(s): - Ben Hogg & Prue Smith 29/11/11	Location, Address and Grid Ref: -	
Listed Grade: - (N/L, N/PL) Local list	Fragility: - (1 – 3)	3	Vulnerability: - (1 – 3) 3
Photographs: -IMG 5069 – 73		BAR Risk Grade: - (A – F)	C
Description/Context: - Hollow post mill. 4 single shuttered patent sails (missing at time of inspection), small boarded buck (on top of main post), 8 bladed fantail and tailpole, all white painted timber. 'Y' wheel, black timber main post 15 ft high and 4 quarterbars to 2 crosstrees on 4 red brick piers. Machinery includes windshaft (with 'spider') and brakewheel (in buck) geared to upright shaft (running down through hollow main post) with drive to scoop wheel in boarded casing. Sluice and brick culvert. Remains rescued from original site in Ranworth in 1981, re-erected and restored by Richard Seago in 1897-88. In reasonable condition, although could do with decorating. Patent sails missing.

Significance: - This hollow post mill is an unusual and important example of the development and history of drainage of the Broads marshes, one of an important group of drainage mills in the Broads area and a feature in the landscape.			
Threat posed: - Timber work requires repair without which deterioration will accelerate.			
Conclusion / Recommendation: -			
Immediate: <ul style="list-style-type: none"> • 			
Medium term <ul style="list-style-type: none"> • 			
Long term:
