Appendix 4: Structures that make a positive contribution to the Conservation Area

The character and appearance of the Conservation Area are shaped by the structures and spaces within it. This appendix contains a list of the built structures which have been identified as making a positive contribution to the Conservation Area (as per section 4. *Positive Contributors* of the CAAMP). The list contains designated as well as undesignated structures. The list is illustrated on maps in the CAAMP.

4.A – The Castle Character Area

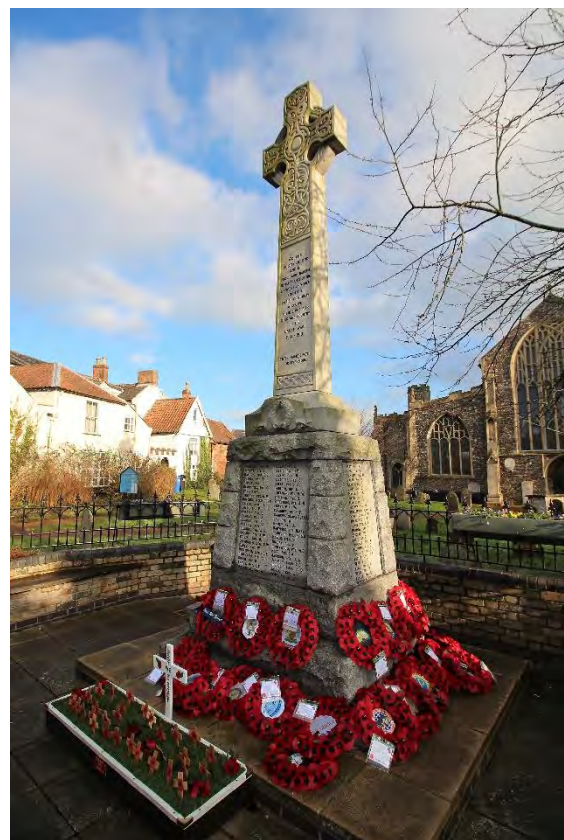
War Memorial, St Mary's Street (grade II). Stone Celtic cross on tall rusticated stone plinth with stepped base. Designed in 1921 by Alexander Macdonald and Co. It commemorates 101 men from the First World War and 37 men from the Second World War who lost their lives.

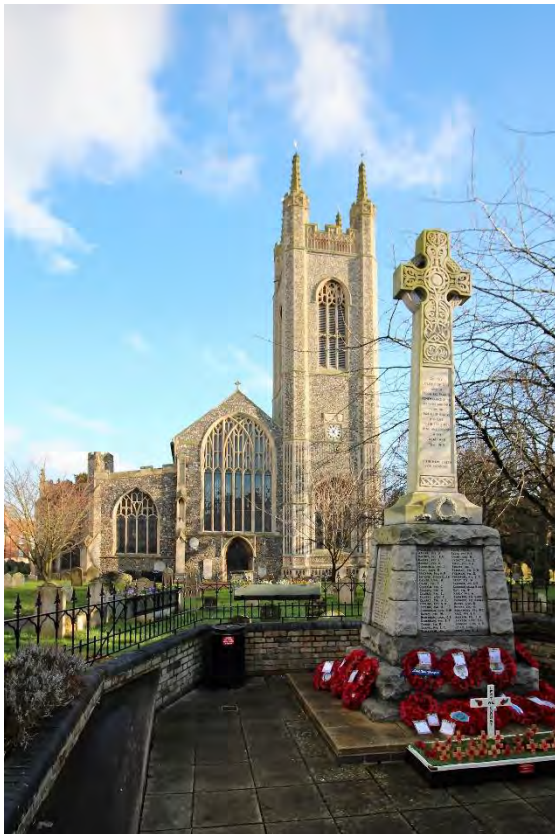
St Mary' Church, St Mary's Street

St Mary' Church and Benedictine Abbey Ruins, St Mary's Street (grade I). A former parish church, closed 1977, and now redundant. Originally this was the Church of the Holy Cross, attached to a Benedictine nunnery, the ruins of which partially survive to the east side of the church. The nunnery was dissolved and partially dismantled at The Reformation and then badly damaged in the fire of 1688. Nave, aisle and porch primarily fifteenth century. The late fifteenth century tower is arguably the dominant feature in the townscape. Its parapet and battlements are of 1702. Octagonal buttresses carried above the parapet as pinnacles. Fire damaged 1688, internally refitted and south aisle re-roofed, as dated on a rafter, in 1699. Church

reopened in 1701. There is no chancel. Vestry of 1819 with wooden tracery in window. Church altered 1832. Nineteenth century restorations by Thomas Jekyll & RW Drew 1861-5, and Richard M Phipson 1879. Much stained glass destroyed in WWII. Bettley, J, and Pevsner, N, *The Buildings of England, Suffolk: East* (London, 2015) p.148-150. Tricker, R *The Priory Church of St Mary Bungay* (London, 2015).

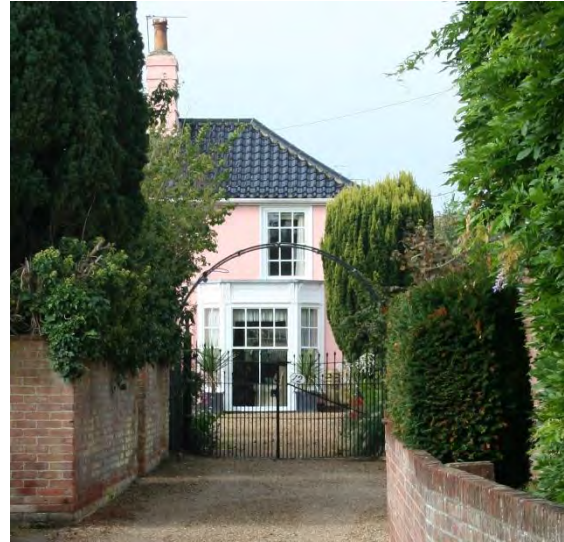
No.12 Trinity Street and boundary wall to rear. Substantial dwelling set back from the road. Probably early nineteenth century. Two storeys rendered facades with a hipped roof with later twentieth century replacement black pan tiles. Principal façade has moulded surrounds to windows and a canted bay window. Central ridge stack. *Subsidiary Structures* Red brick and cobble boundary wall to rear. Boundary walls to Trinity Street appear to be late twentieth century red brick structures.

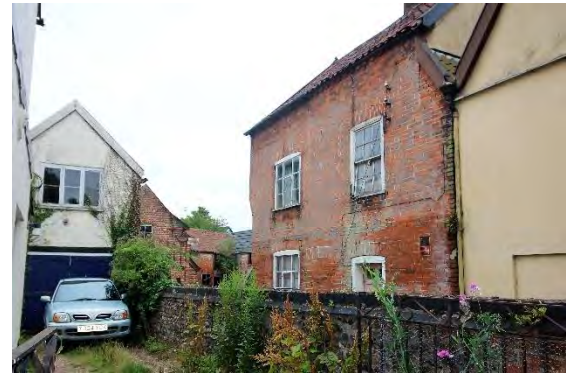
Rear range and outbuildings at No.26 Bridge Street

Substantial rear range with red brick façade, which was possibly originally a separate dwelling. Two storeys with a two-bay principal façade facing towards the river. Casement windows beneath cambered brick lintels, one hornless twelve-light sash at first floor level. Blocked door opening to ground floor centre. Good group of probably early nineteenth century red brick outbuildings in yard to the rear of No.26 including gabled cart shed with loft above. Red pan tiled roofs some now missing. Last used as an abattoir. Nos.2, 4, 6A, 12 to 20 (even), 24 to 34 (even) 40 to 44 (even), 48 and 50 form a group.

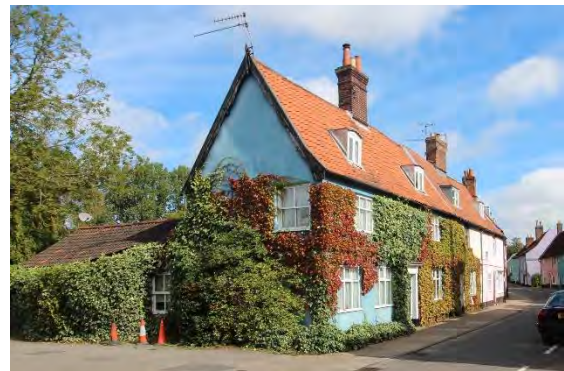
No. 29 Bridge Street

No.29 Bridge Street (grade II). Seventeenth century, of two storeys and an attic. Steeply pitched red pan tiled roof with two flat roofed dormers. C1900 photographs however show the building with gabled dormers. Cement rendering on brick, with a first floor platt band. First floor lit by two three-light casements which replaced the sash windows shown on early photographs. Early nineteenth century six panelled front door described in statutory list now replaced with a partially glazed one. Good doorcase with pilasters and a dentilled cornice. Ground floor shop fascia replaced by further casements. Single storey range to rear with casement windows and a red pan tiled roofed. Nos.29 to 45 (odd) form a group. Honeywood F, Morrow P & Reeve C, *The Town Recorder, A History of Bungay in Photographs* (Bungay, 1994) p156.

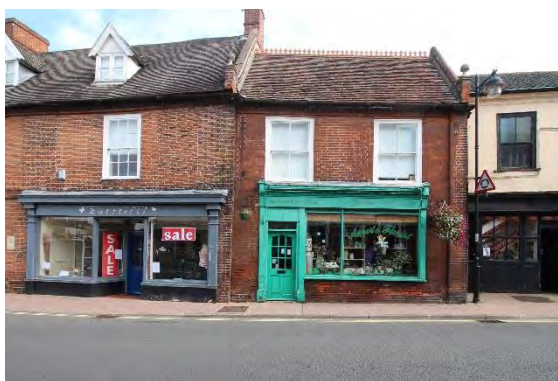
No.4a Earsham Street

No.4a Earsham Street. A structure of c1870 consisting of a shop with living accommodation above which replaced a timber-framed gabled building which is shown on early photographs. Of two storeys and two bays and faced in red brick with a red plain tile roof and terracotta ridge pieces. Southern gable with finials and dentilled cornice. Its present façade is radically different from that shown in Edwardian photographs, which show a central canted bay window at first floor level and a central doorway flanked by two small pane sashes below. Four light horned plate glass sashes at first floor level. Dentilled eaves cornice. Early to mid-twentieth century shop fascia, with late twentieth century partially glazed door inserted post 1977 within the original fascia. Reeve C, *Bungay Through Time* (Stroud, 2009) p38.

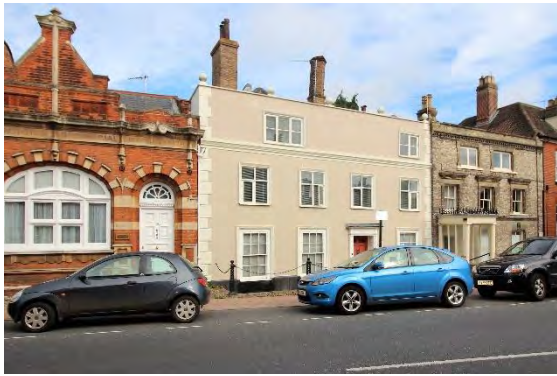
No.16 Earsham Street (grade II). A substantial seventeenth century townhouse, which is reputed to have been built in 1620. Three-storey, four-bay, stuccoed façade to Earsham Street with rusticated quoins and a parapet capped by ball finials. Moulded plaster plat band beneath second floor windows, moulded cope to parapet. Four original mullioned and transomed casements with stucco architraves at first floor level. Eight-panelled door, right of centre, in wood case with panelled reveals, pilasters and entablature flanked by twelve-light sashes. Black pan tile roof with gault brick stacks. Some original interior doors. Nb. C1900 photos show the house without the present second floor and parapet but with dormers set within the roof this part of the façade is however evident in c1930 views. Nos. 2 to 40 (even) form a group. Honeywood F, Morrow P & Reeve C, *The Town Recorder, A History of Bungay in Photographs* (Bungay, 1994) p148.

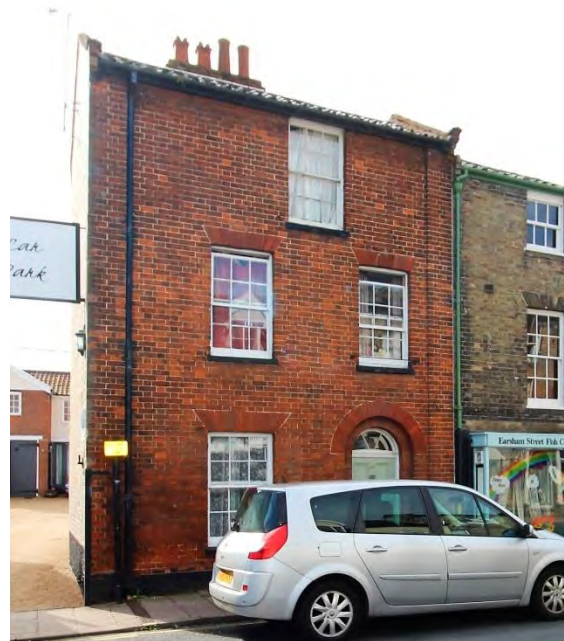
No.37 Earsham Street

No.37 Earsham Street. A red brick dwelling of c1830-40 with a two bay three storey principal façade. Two storeys rear elevation. Pilaster to right of door. Panelled front door recessed within arched opening. Simple semi-circular radial fanlight. Wedge shaped lintels to hornless sash windows and stone sills. Some sashes replaced. Red pan tile roof covering and massive red brick chimneystack. Rear elevation facing the Castle is rendered and painted with four-light plate-glass sashes. Two storey outshot with a red pan tile roof probably of contemporary date. The rear section of the plot on which this building stands is within the scheduled area of the Castle complex.

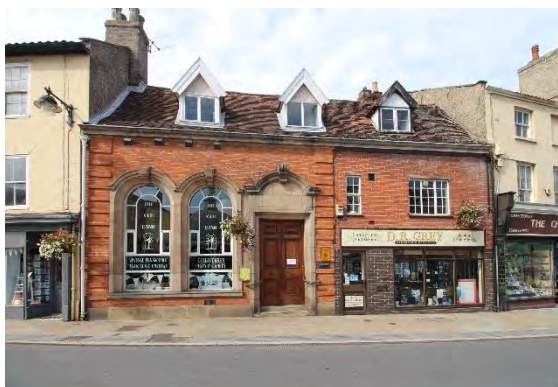
No.8 Market Place

No.8 Market Place. Former bank and shop. c1900 red brick classical façade with stone dressings to an earlier structure. 1880s photos show a stuccoed early to mid-eighteenth century building of similar proportions on this site. Red plain tile roof with a row of three gabled dormers with bargeboards and casement windows. Rusticated red brick pilasters. Full height arched windows to left-hand section with heavy moulded surrounds and pronounced keystones. Doorcase with similar surround with robustly carved scrolled keystone. Right-hand section with small pane metal casement windows to first floor and late twentieth century shop fascia. The rear section of the plot on which this building stands is within the scheduled area of the Castle complex. Honeywood F, Morrow P, & Reeve C, *The Town Recorder, A History of Bungay in Photographs* (Bungay, 1994) p135.

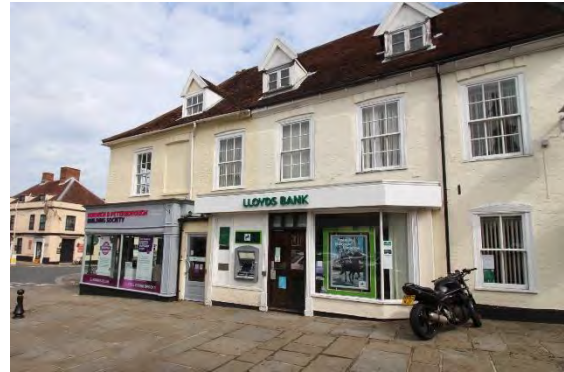
Nos. 9 & 11 Market Place (grade II). An early eighteenth century building on a prominent corner site. Of two storeys with attics which are lit by gabled sash dormers. Colour-washed brick. Red plain tile roof covering. Principal elevation of six bays and a return elevation of four. Flush framed twelve-light hornless sashes beneath rusticated cambered arches to first floor. Entrance door with fanlight and wood case. Mainly modern shop fronts. Originally one building. Essentially part of the old market. Nos. 1 to 11 (odd), Nos. 11A, 13 and Nos. 17 to 21 (odd) form a group together with the Butter Cross.

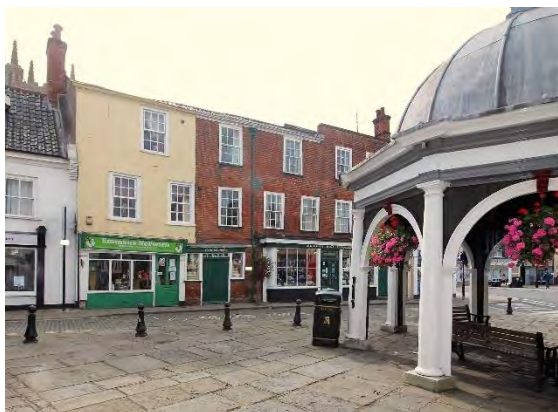
Nos.15-19 (odd) Market Place

Nos.15,17,19,19a & 21 (odd) Market Place (grade II). A three storey eighteenth century red brick range backing onto Saint Mary's Churchyard. Market Place façade of seven bays. With a red pan tiled roof. (No. 15 now painted). Wooden modillion eaves cornice survives to Nos.15-17 but replaced by parapet above Nos.19 & 21. Seven twelve-light sash windows to the first floor in flush frames beneath flat arched lintels. Those to No.19 with horns. Windows to No.17 regrettably replaced by casements. Early nineteenth century wooden shop fascia to No.17. Well-preserved early nineteenth century shop front to part of Nos.19 and 21, with

pilasters and entablature. Nineteenth century glazing bars, except to patterned fanlight. No.15 is described in the listing entry but its numbering is incorrect.

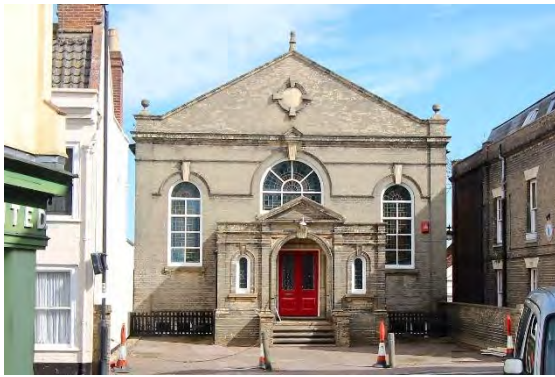
Former Wesleyan Methodist Chapel, Trinity Street

*Former Wesleyan Methodist Chapel, Trinity Street and boundary wall to Borough Well Lane. Former Wesleyan Methodist Chapel with basement schoolrooms built 1836, re-fronted and refitted 1904. Repaired after 1940 bomb damage, in 1948. Closed 1976, when some fittings were removed to Emmanuel Church. Façades to Trinity Street and Borough Well Lane which are well preserved and retain the bulk of their original joinery and stained glass. Its Trinity Street façade terminates views along Cross Street. Pedimented gault brick façade to Trinity Street of three bays with corner pilasters capped by ball finials. Three arched casement windows with pronounced keystones. Pedimented projecting single storey porch. Elevation to Borough Well Lane of an additional storey and faced in red brick. Tall nineteenth century gault brick boundary wall to Borough Well Lane of considerable townscape value. Red brick retaining walls to rear of lesser interest. Honeywood F, Morrow P, & Reeve C, *The Town Recorder, A History of Bungay in Photographs* (Bungay, 1994) p17 & 27. Bettley, J, and Pevsner, N, *The Buildings of England, Suffolk: East* (London, 2015) p.157.*

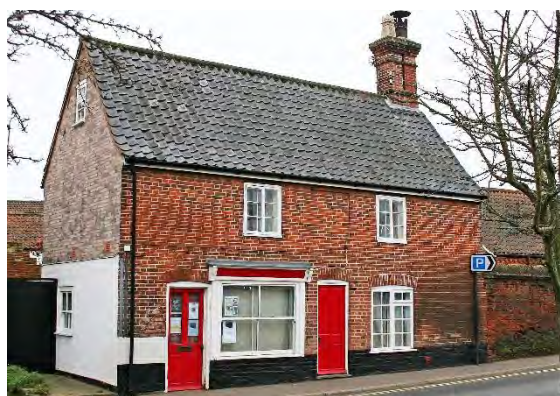
No.4 Lower Olland Street

No.4 Lower Olland Street. Two cottages, latterly house and shop. Red brick with a steeply pitched black pan tiled roof. Possibly late eighteenth century. Well preserved later nineteenth century shop fascia to southern end of a single bay. Two centrally opening casements to first floor which are possibly of nineteenth century date flanking a central blind recess. Southern return elevation partially rendered with replaced windows. Door and widow openings to ground floor with cambered brick lintels. Ground floor window at northern end now a late twentieth century four pane casement. Northern elevation rendered. Single storey rear range.

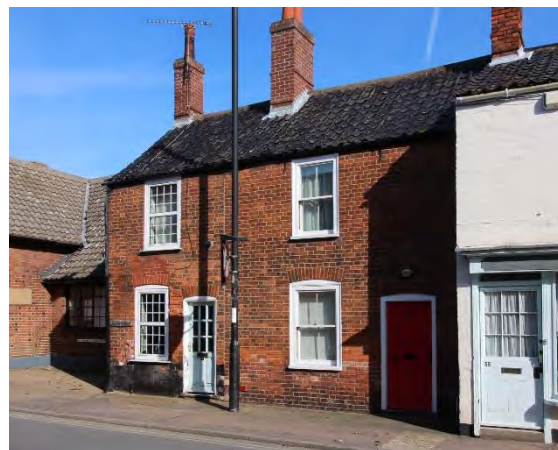
Nos.31-33 (odd) Lower Olland Street

Nos.31-33 (odd) Lower Olland Street. A pair of red brick terraced house of c1800 with a black pan tiled roof. Cambered arched lintels to window openings. External joinery replaced in the late twentieth century. Straight joint between the two properties.

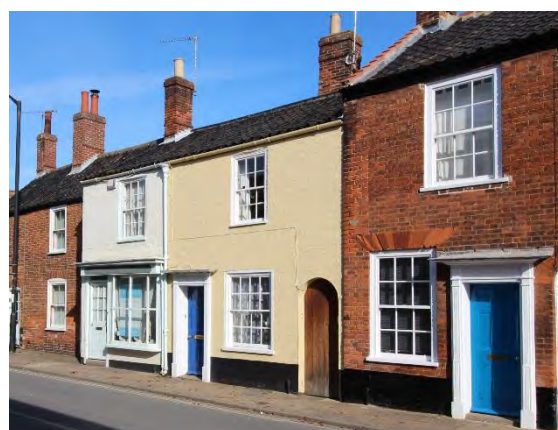
Nos.35-37 (odd) Lower Olland Street

Nos.35-37 (odd) Lower Olland Street. A pair of red brick terraced houses of c1800 both now painted. No.35 with a mid to late nineteenth century shop facia, and a replaced partially glazed door. Twelve-light hornless sashes. Black pan tiled roof. Simple pilastered doorcase to No.37 and arched passage entrance.

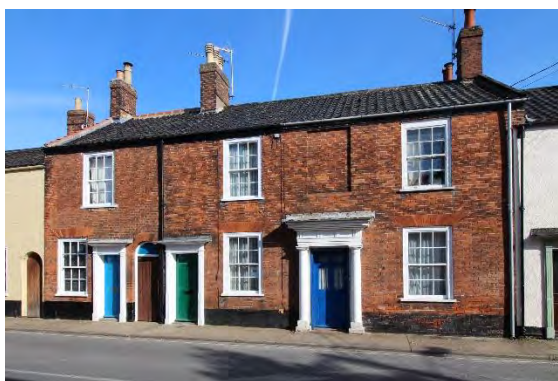
Nos.41-45 (Odd) Lower Olland Street (grade II). Later eighteenth or early nineteenth century, of two storeys, red brick, black pan tiled roof. Six bay façade with replaced sash windows within flush frames to each floor. Flat arched lintels to ground floor. Nos.41 and 43 have six-panelled doors in wooden cases with pilasters. No.45, a six-panelled door within an altered wooden doorcase with Doric pilasters. Blind recess above. Arched passage between Nos.41 and 43,

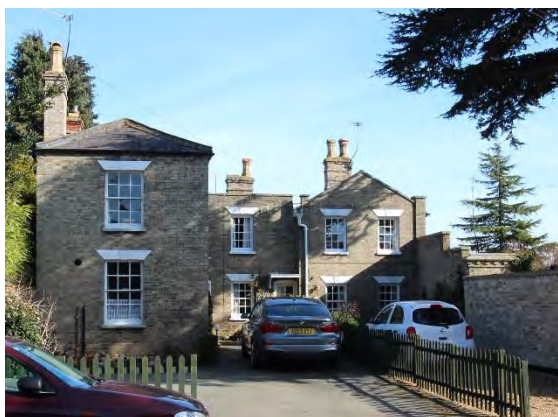
Nos.61 & 63 Lower Olland Street

*Nos.61 & 63 Lower Olland Street. A semi-detached pair of houses of mid nineteenth century date. Possibly originally one villa but map evidence suggests it has been divided since at least 1905. Two storeys. L-shaped, No.61 within projecting range at northern end with a hipped Welsh slate roof. Good Doric doorcase. Twelve-light hornless sashes beneath painted stone flat-arched lintels with rusticated panels. No.63 has parapet hiding roof and gable to southern bays. Twelve-light hornless sashes. *Subsidiary Structures.* Tall mid nineteenth century gault brick wall springing from entrance façade of No.63.*

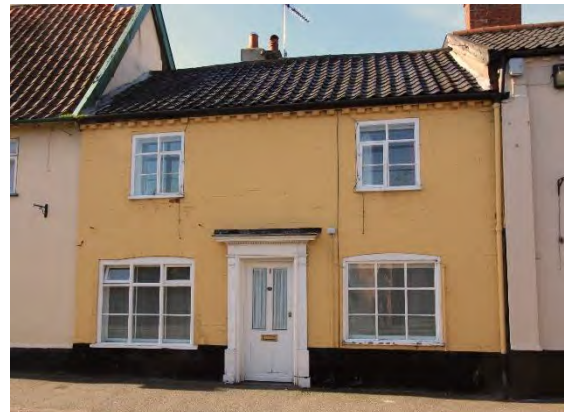
No.20 Upper Olland Street (grade II). Eighteenth century with a two storey, three bay symmetrical façade of painted brick. Black pan tiled roof. Dentilled brick eaves cornice. Two flush casements at first floor level. Central doorcase with pilasters and a dentilled cornice. Partially glazed four-panelled door flanked by two six-light casements beneath cambered brick arches. The left-hand casement is slightly wider than its lintel and replaces a late nineteenth century pub facia. Formerly the Greyhound Inn (closed 1913). Honeywood F, Reeve C, & Reeve T, *The Town Recorder, Five Centuries of Bungay at Play* (Bungay, 2008) p99 % 154.

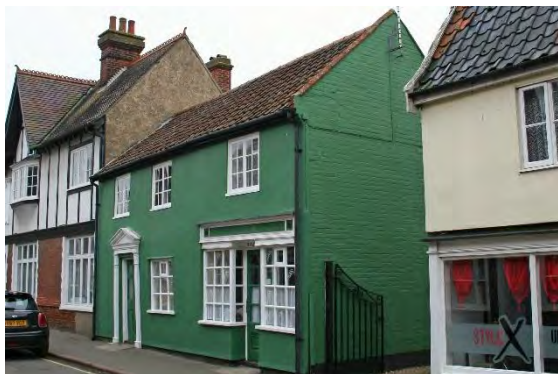
No.26 Upper Olland Street

No.26 Upper Olland Street. Probably of early nineteenth century date but much altered. Painted and rendered red brick. Red pan tiled roof. Three small pane casement windows to first floor. Late twentieth century pedimented doorcase and shop fascia. Whilst much of the external joinery has been replaced the openings correspond to those shown on early twentieth century photographs. The building has significant group value with neighbouring properties.

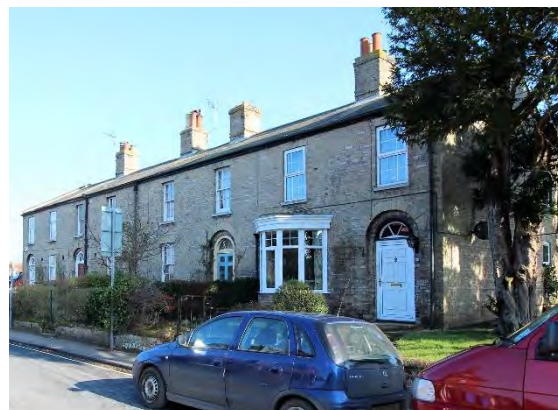
Nos.38-44 (even) Wingfield Street

Prospect Place, Nos.38-44 (even) Wingfield Street. Gault brick terrace of four houses. Two storeys, each house of two bays. Original hornless twelve-light sashes now only survive to No.42. Flat-arched lintels, stone sills. Front doors within shallow arched recesses, radial fanlights. Six-panelled doors now largely replaced. No.38 with late twentieth century canted bay window.

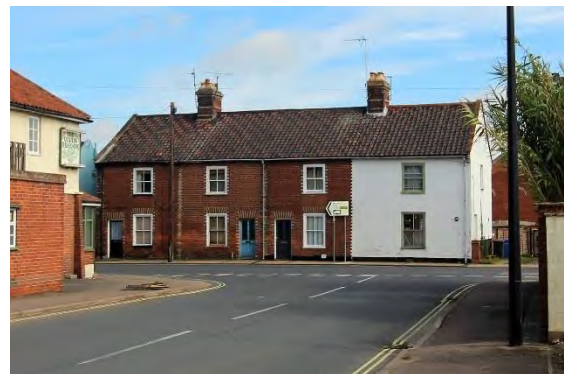
Nos.40-46 (even) Broad Street including boundary wall of No.46 to Stone Alley. A terrace of four later nineteenth century cottages. Red brick with gault brick embellishments. No.40 now painted. Roof covering partially red and blue pan tiles in a geometric design and partially replaced with red pan tiles. Two shared red brick ridge stacks. Four-pane, horned, plate-glass sashes. Gault brick quoins separating cottages, and alternate gault and red bricks to wedge shaped lintels for both doors and windows. Sides of window and door openings also have gault brick embellishments. Partially glazed front doors. No.40's front door has been moved to the return elevation. No.46 has a good series of early nineteenth century or earlier boundary walls of brick and rubble to Stone Alley.
