Unauthorised Development with Navigation Implications
Report of Planning Officer (Compliance and Implementation)

Summary: Works at Barnes Brinkcraft in Hoveton has not been in accordance with the approved drawings, which has resulted in encroachment into the navigation area from a build-out and vessels moored to an incorrectly located pontoon.

Appendix 1: Photographs of unauthorised development

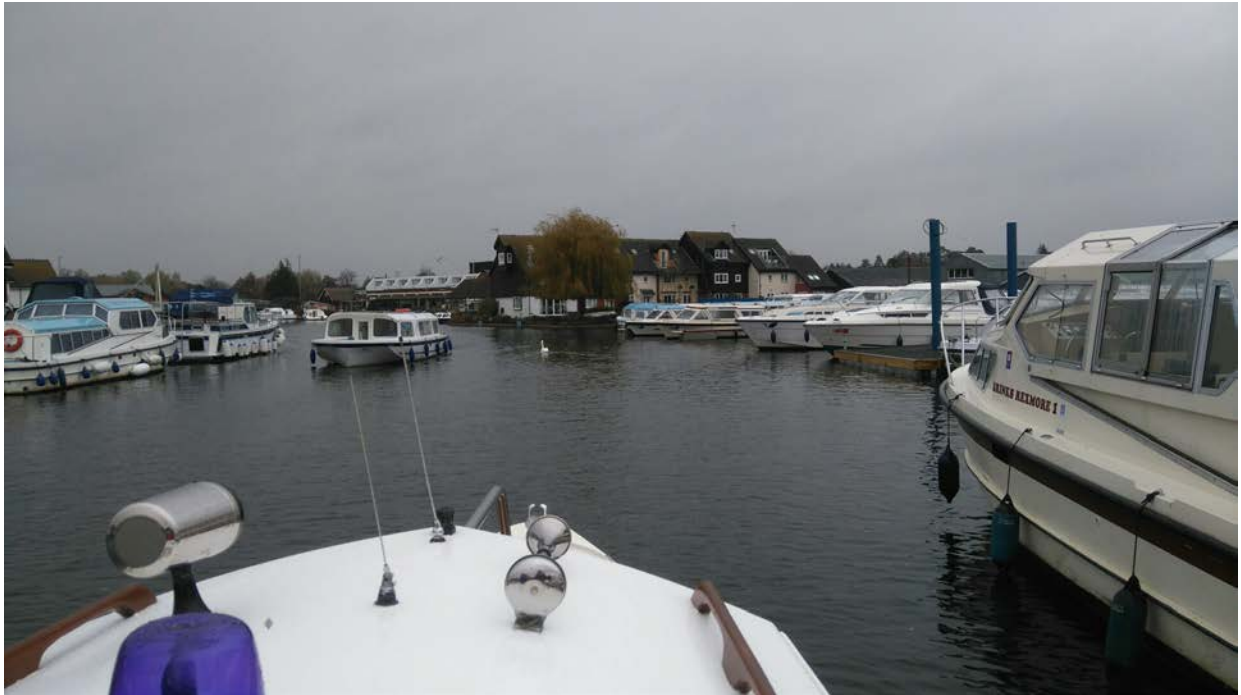
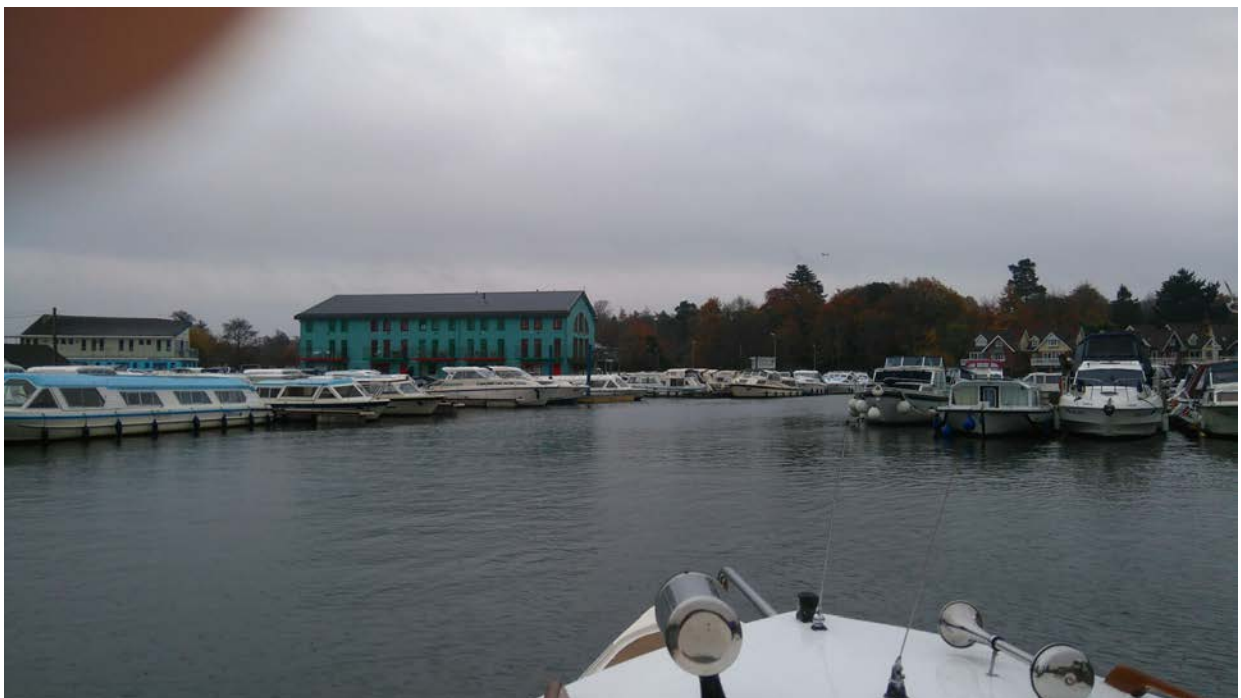
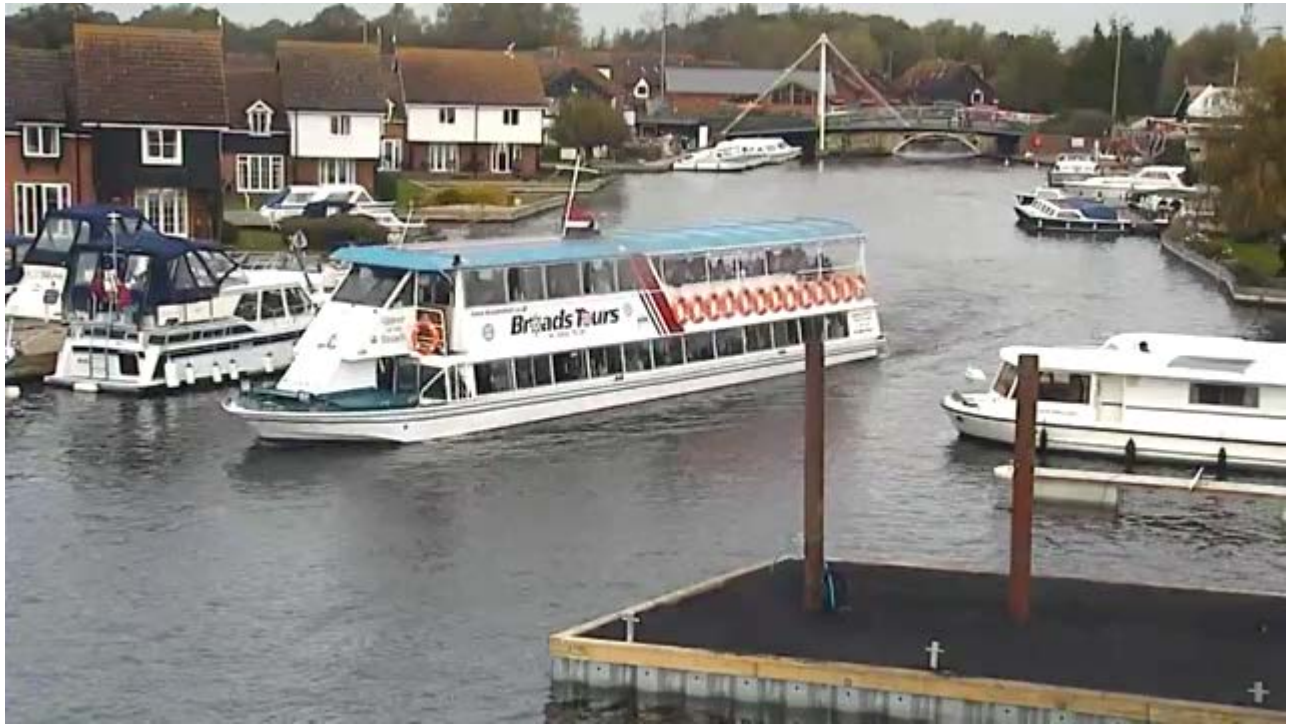
- a. A spit of land downstream of the basin, which runs perpendicular to the river and separates this mooring basin from another mooring basin, has been extended out into the river by approximately 1.2m; and
- b. The new pontoon has been located approximately 4.2m closer to the river than proposed on the approved drawing; and
- c. The configuration of the moorings on the new pontoon is not as shown on the approved drawing.

These are illustrated by the photographs in Appendix 1

- 2.2 The operator has explained in respect of (a) that the land has been restored to a previously existing extent, the former land having been removed at some point in the past by a previous owner. In respect of the pontoon at (b), it should be noted that it is 0.5m narrower than permitted and that the approved drawing shows the guide piles located to the front (riverside) of the pontoon, whilst on site they are located to the rear.

- 2.3 The cumulative effect of the above changes is that the navigation channel has been narrowed, both by the encroachment of the extended land and the encroachment effect of vessels mooring on the new pontoon. The extent of the encroachment by moored vessels will depend on their length, however as the pontoon is approximately 3.7m further forward (taking account of its reduced width) than previously shown, there remains potential for encroachment by vessels of an average length. It should be noted that initially vessels of up to 10.5m in length were being moored on the new pontoon, but when advised of the issues the operator moved these and limited the length to 7.5m.
