**Broadland Flood Alleviation Project:
Compartment 37 (Upton Dyke) - Piling Removal Works and the Installation of
Erosion Protection - Application for Discharge of pre-commencement
conditions linked to planning permission (BA2015/0364/FUL)
Report by Planning Officer**

COMPARTMENT 37, UPTON DYKE PILING REMOVAL PLANNING APPLICATION CONDITION DISCHARGE (BA/2015/0364/FUL)

Construction Traffic Management Plan for Compartment 37 Upton Dyke Piling Removal

Upton Dyke Piling Removal: Management Plan

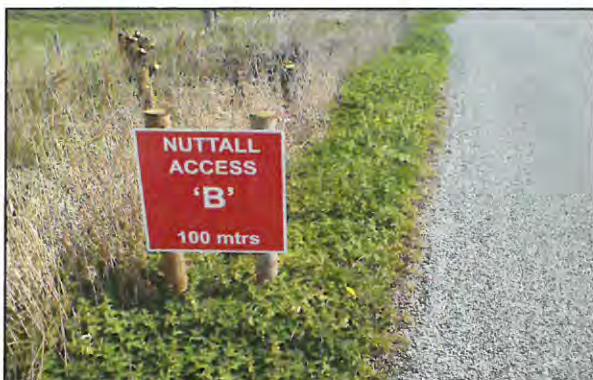
The photos below shows typical road signs that will be positioned in the road verge 100m in both directions from the access points, with a separate sign at the actual access point. Similar signage has been used to good effect in other compartments.

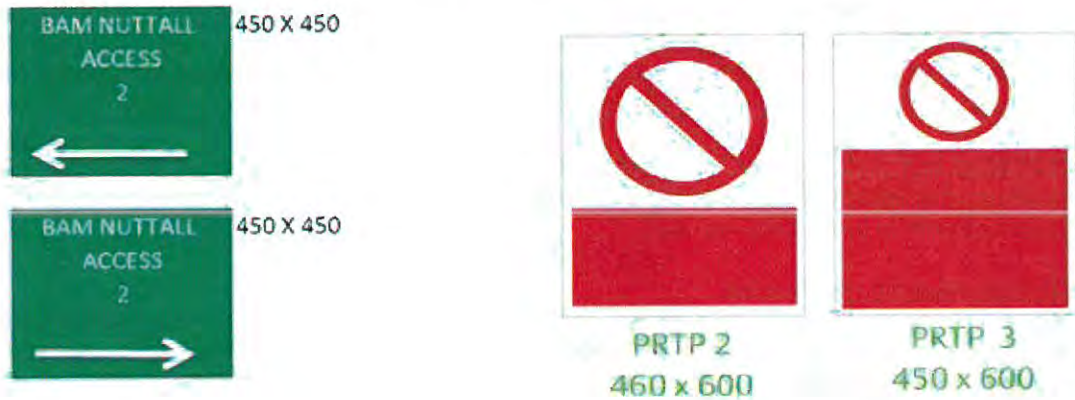
These signs will be used to clearly mark out the access routes to the working corridor and to prevent vehicles using roads not identified in the construction traffic management plan. Signs can be annotated to apply to specific vehicles or deliveries; e.g. "Low Loaders".
